TECHNICAL CONDITIONS OF THE UNIQUE STRUCTURE OF INVERTED SIPHON – HISTORY & PRESENT

Jacek HULIMKA a*, Marta KAŁUŻA b

An inverted siphon is sometimes used to enable a watercourse to pass under an obstacle. Such solution is usually applied for irrigation and sewage canals, but it is rarely observed in the case of rivers. There are two such passages in Poland the bigger one is the Klodnica River siphon under the Gliwice Canal, commissioned in 1936. The first part of the paper presents the history of the Gliwice Canal and, simultaneously, of the Klodnica River siphon. The further part describes the structure of the siphon and its usage assumptions as well as the technical condition of the construction after nearly 80 years of operation, including inspection results concerning the underwater parts. The description is supplemented with results of chemical examinations. Basic repair recommendations are also provided.

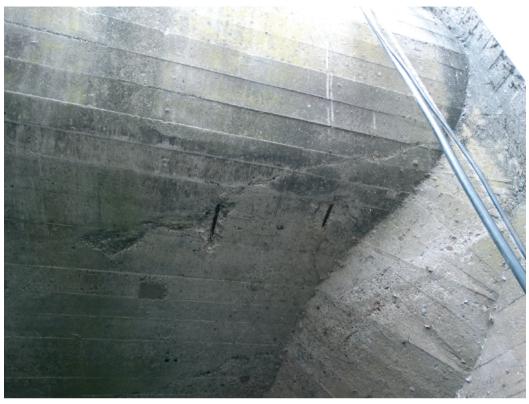
The technical state of the structural elements permanently underwater was very good and showed virtually no damage. The only exception was slight damage at the inlets to the individual pipes, caused by flowing tree trunks hitting them during floods. The uncovered rebars underwent corrosion in this spots (Fig. 7). Interestingly, the transverse expansion joints of the individual pipes showed no leaks from above (Fig. 8), which proves that the Gliwice Canal bed insulation was perfectly performed and is still effective (according to [13], the canal bottom section above the siphon was sealed with a loam layer, while the structure itself was insulated with bituminous materials; according to [15], full watertight facing of the bottom was applied only on a 200 m long section of the canal beyond the siphon zone and had the form of a basalt breakstone skeleton filled with a liquid mixture of mastic asphalt and covered with a layer of sand asphalt concrete with a thickness of approx. 30 mm).

Figure 7. Damaged inlet of the duct with corroded reinforcement

Given the technical state of the structure and the excellent quality of concrete in the underwater (siphon) part, the latter may be operated virtually without repairs. The local damage from the inlet side of pipes No. 1 and 2 caused by hitting objects is an exception here. Those spots require local repairs using any PCC (Polymer Cement Concrete) system.

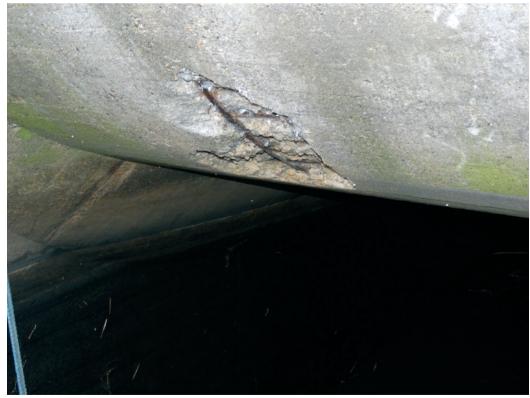
Figure 8. The expansion joint with no leak of water above

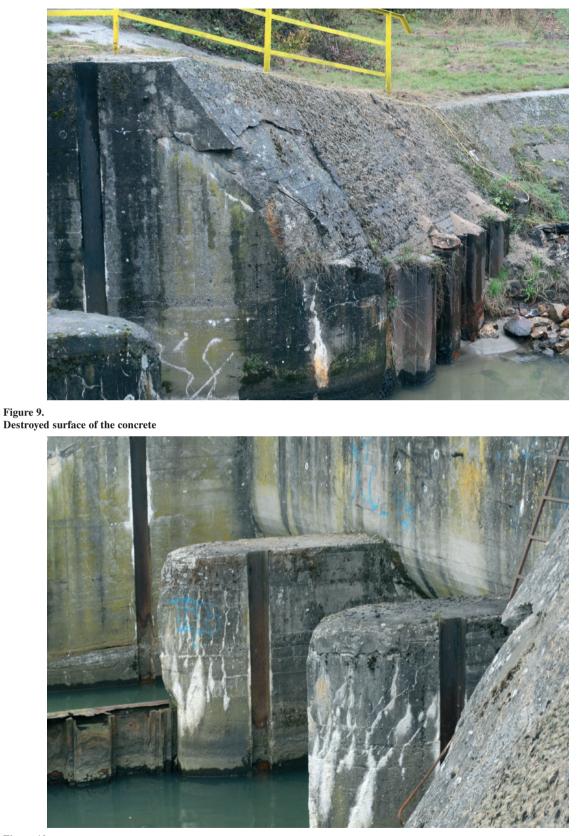
Figure 10. Destroyed surface of the concrete with the streaks of acid calcium carbonate

The technical state of all the reinforced concrete elements of the part above the water was much worse: the surface layer of their concrete was destroyed to a large extent; in certain spots, deeper concrete layers were destroyed as well (Figs. 9, 10). The deeper damage was accompanied by reinforcement corrosion. The structure part above the water has been exposed to a constant impact of its surroundings for nearly 80 years. That impact has shown great variability, especially in the scope of temperature and humidity. Such conditions are highly unfavourable to concrete structures, so the majority of the observed damage is corrosive and perfectly natural in those circumstances. However, the effects of the corrosion affecting the surface layer of concrete are strengthened by the damage caused by a volume increase of corroding reinforcement inserts. This results in negative synergy of the destructive effects of concrete and steel corrosion. It must be highlighted that the Klodnica River was heavily polluted with industrial wastewater for many years, which intensified the aggressive action of water on the structural materials.

Certain parts of the concrete surface were densely overgrown with moss and lichens, which also contributed to the material surface destruction due to biological corrosion. Moreover, the edges of the heads and walls showed many traces of mechanical destruction caused by flowing objects hitting them during floods and by the roots of trees growing along the canal which gradually made them burst.

The state of the external parts of the structure (those above the water level), especially the heads and the endings of the partitions between the pipes, is much worse because they show highly advanced corrosion of concrete and rebars. That damage does not constitute a breakdown hazard for the entire structure due to its location, but its scope must be treated as serious. Therefore, those elements require comprehensive repair and protection. Special attention should be paid to the necessity of removing the weakened or degraded cover fragments, removing the corrosion products from the reinforcement, filling in the excessive reinforcement losses and correct reprofiling of the elements. It is extremely important to adjust the repair system to the substrate parameters (due to the relatively low concrete durability) and to the structure operation conditions. It is recommended to perform hydrophobization of all the concrete structures after repairing them.

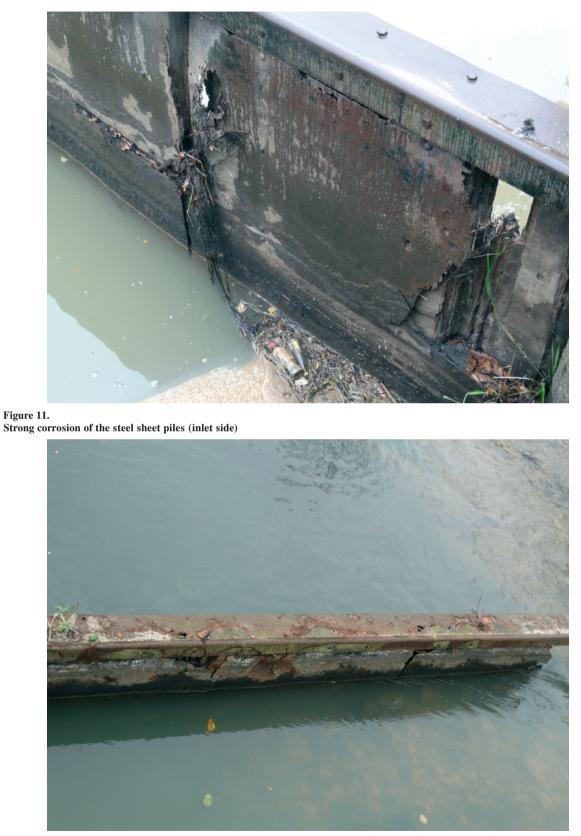
Figure 12. Bad condition of the steel sheet piles (outlet side)

The technical state of the steel sheet piles in all those elements was very bad; some of them were completely destroyed (Figs. 11, 12). The walls were later reinforced with sheet metal in many spots, but it also underwent complete corrosion. The most significant damage was observed close to the water surface, i.e. in the zone of variable exposure of the elements to contact with water.

When analysing the results of chemical tests of concrete, one can observe a significant concentration of sulphate (SO_4^{2-}) ions, which probably partially come from the heavily polluted waters of the Klodnica River. These are undoubtedly not the only aggressive factors in the water because the Klodnica River collected industrial wastewater from numerous Upper Silesian plants for years, which explains the observed corrosion of the steel elements.

The sheet pile walls are damaged to a varying extent; some of them are completely destroyed. They require a comprehensive improvement or, preferably, replacement (if they are necessary from the operation point of view).

A project concerning a comprehensive improvement of the siphon structure was implemented in the first half of 2017; it included replacement of all the sheet pile walls as well as clearing and reinforcing the river banks downstream and upstream of the siphon. Project implementation is anticipated for 2018 or 2019.
