SLOPE FAILURE CAUSED BY AN INCORRECTLY SELECTED REINFORCEMENT

The paper presents the case of the slope failure of a deep drainage channel caused by the geotextile clogging phenomenon resulting from selecting an inappropriate material with respect to soil parameters.

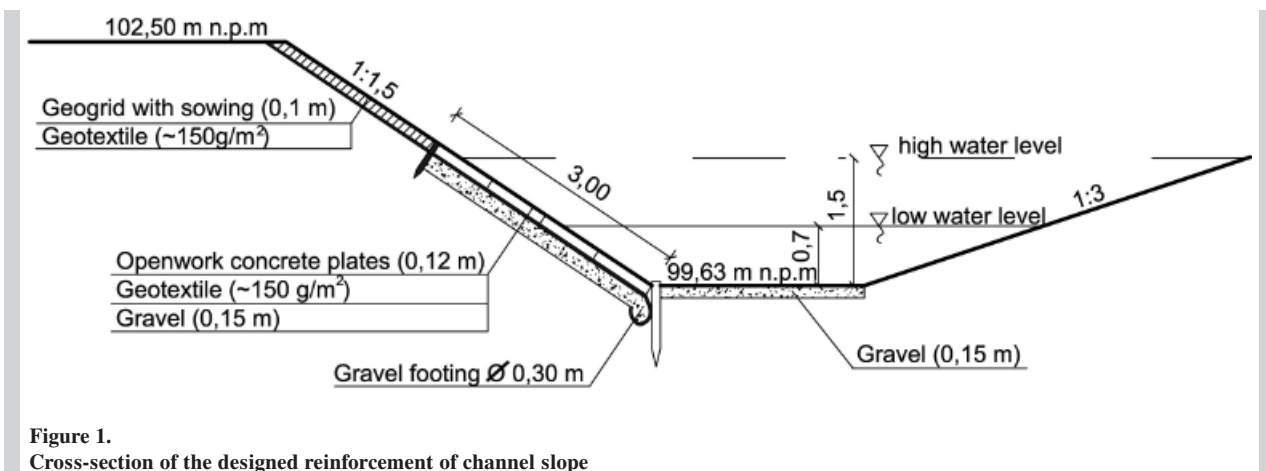
Analysed slope was reinforced by geotextile, geogrid and openwork concrete plates (Fig. 1).

Figure 1.
Cross-section of the designed reinforcement of channel slope

In the upper part of the slope, a geogrid made from PEHD was placed above the geotextile, while in the lower part of the slope a 0.15 m thick layer of gravel was laid under the geotextile, covering non-permeable sandy silty clays. A gravel footing was formed at the base of the slope, on the side adjacent to the channel. It was covered by the geotextile, which made it impossible to effectively discharge the water from the gravel layer to the bottom of the channel (Fig. 1) [2].

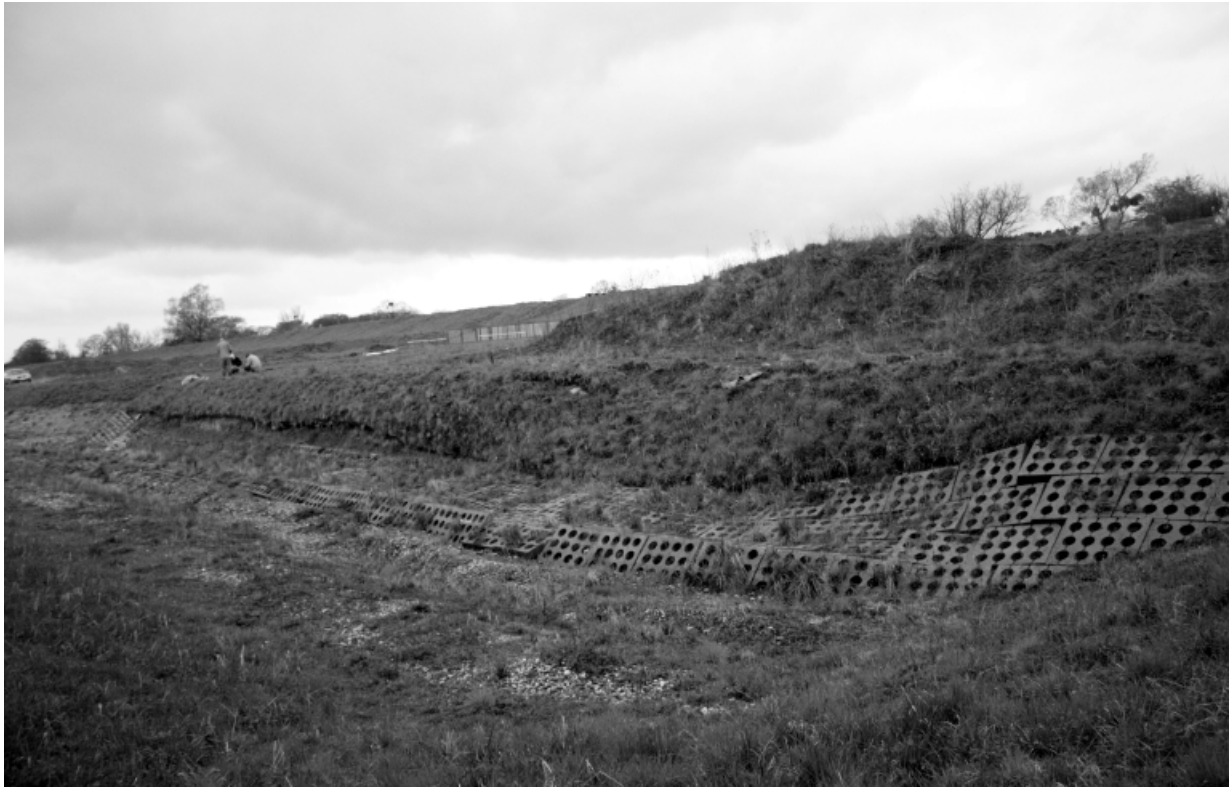
After the designed reinforcements had been constructed, even before the commencement of operation, a superficial failure of the lower part of the slope occurred on a section of the channel. It was caused by rainfall waters that had flowed down from areas located above the channel edge and penetrated into the constructed reinforcements. This resulted in the damages shown in Figure 2.

Figure 2.
View of the slope after the failure (private collection)

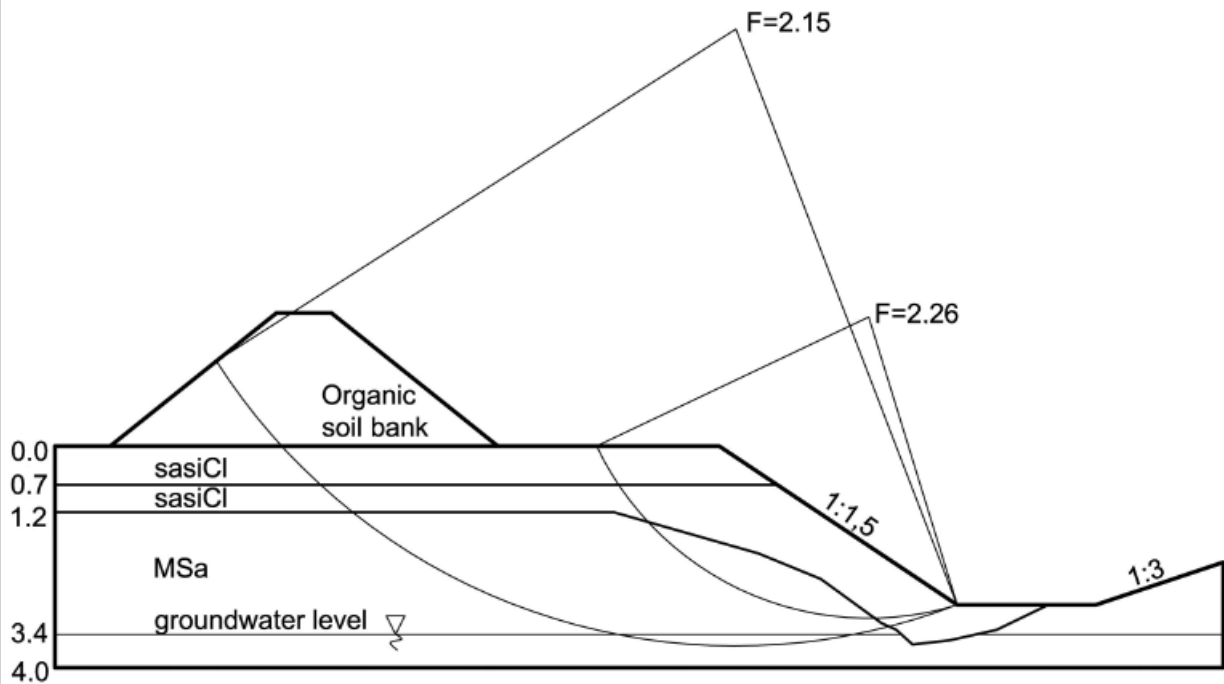
Based on obtained soil parameters, the slope stability for 2 most disadvantageous variants of circular slip lines location were calculated using the Bishop method. Determined safety factors equalled $F = 2.15$ and $F = 2.26$, so they were higher than the required value $F = 1.30$ (Fig. 3) [4]. This means that the gravity safety of the slope, even taking into account the load resulting from the organic soil stored nearby would not be destroyed (Fig. 3).

Figure 3.
Calculation scheme of the slope with most disadvantageous slip lines

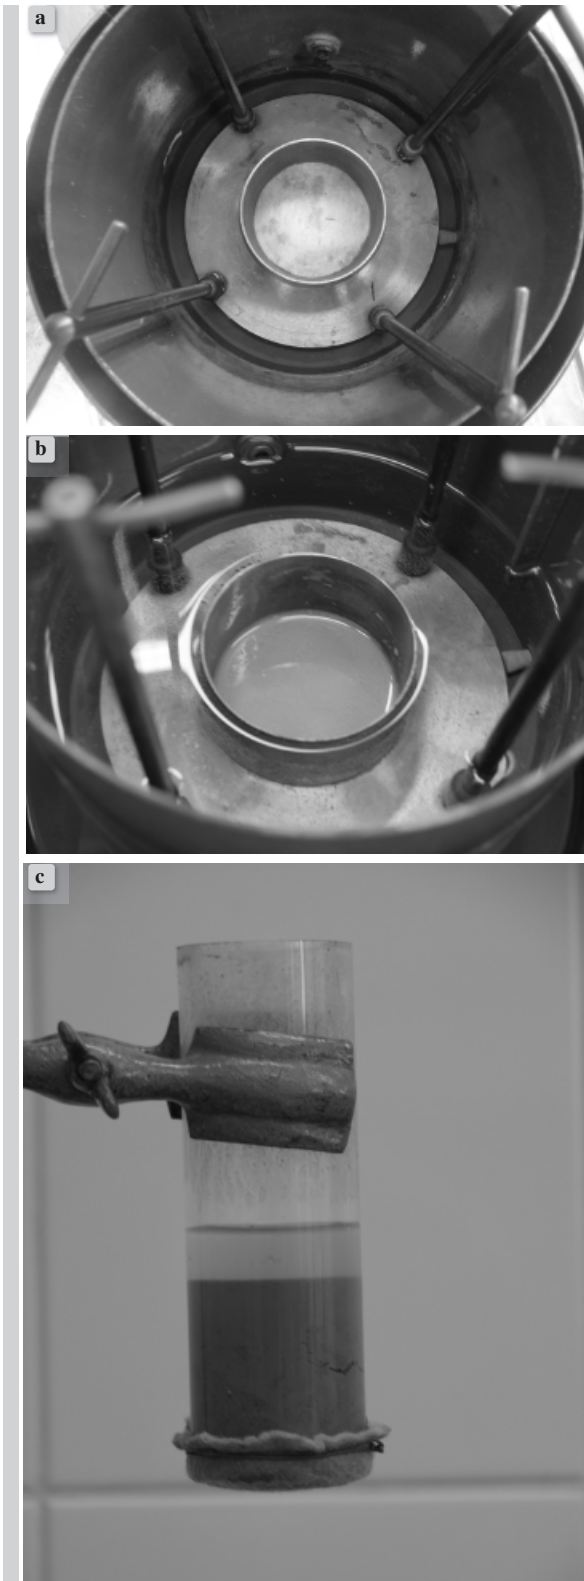
Figure 4. Tests of water permeability of the geotextile; a) flow of water through geotextile; b), c) flow of clay suspension through the geotextile

geotextile alone (Fig. 4a) and in the conditions of possible clogging with water suspension of clay (Fig. 4b, 4c).

The values of filtration coefficient of the geotextile obtained as a result of the tests (Tab. 2) were significantly lower than data specified in catalogue that equals 0.078 m/s, [1].

In order to check the results of geotextile clogging, a suspension of clay in water was filtered through the geotextile (Fig. 4b, 4c), which demonstrated a significant decrease in water permeability (Tab. 3). For the purposes of comparison, the proneness of geotextile to clogging was also tested basing on the granulation criterion proposed in hydrotechnical construction according to Loudiere [3], where two following requirements should be met at the same time:

The conducted analysis confirms the result of the laboratory test that demonstrated that geotextile was clogged with the clay used in water and soil mixture.

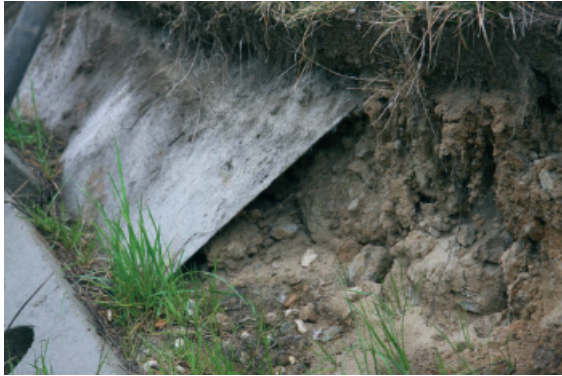
Based on conducted research and analysis as well as considering the nature of the slope damage it was found that the failure started from the level where openwork concrete plates were laid on the surface of the slope. This occurred during intense rainfall (85 mm) on the surface of non-permeable soils. Taking into account the additional discharge of water from the heap of deposited organic soil (Fig. 3) it was calculated that approx. 15 dm^3 of water flowed down the surface of a 1 m long section of the slope during 48 hours. The water retained in the openings of the geogrid infiltrated into the gravel layer located in the bottom part of the slope (Fig. 5).

Figure 5.
Hollow space below the geotextile caused by moving the soil to the gravel layer located underneath the concrete plates (private collection)

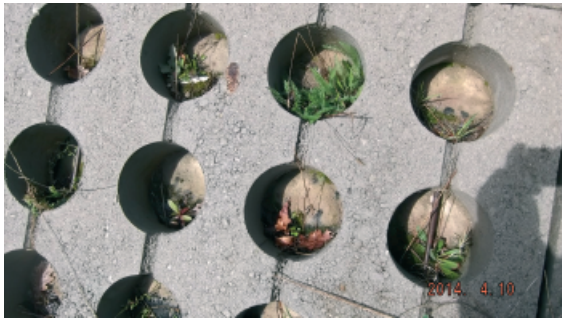
Figure 6.
Openings in concrete plates with geotextile on the bottom side (private collection)

coefficient (Tab. 2). In addition, conducted tests of clay suspension permeability through the geotextile (Tab. 3), as well as the computational analysis confirmed that in this ground-water condition the geotextile is prone to clogging. This resulted in an excessive water pressure below the open plates, which is proven by the displacements of geotextile in form of bulges in the plates openings (Fig. 6).

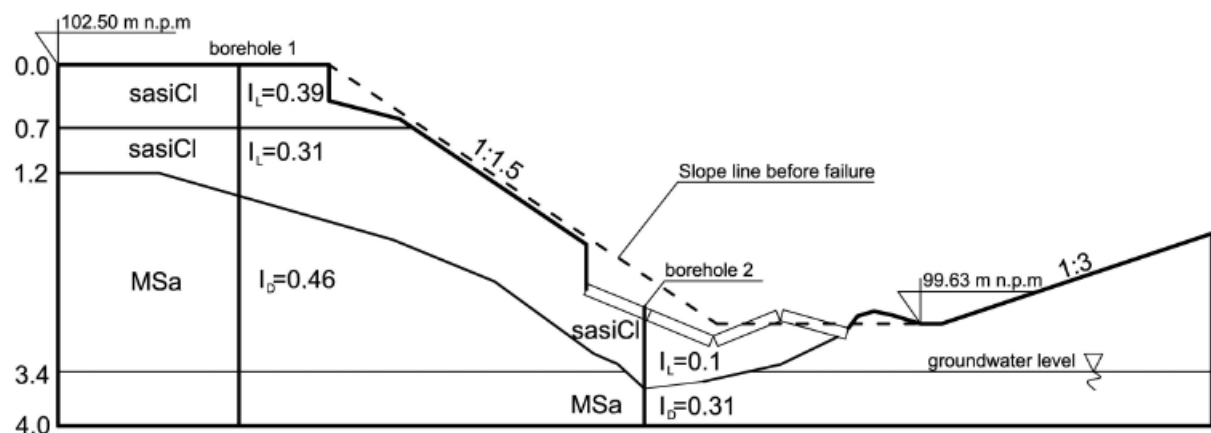
The resulting gradual soaking of the clay underneath the gravel led to a decrease in its strength properties, which in turn, caused a failure in the lower part of the reinforcement (Fig. 7).

In order to evaluate the results of soaking of clay characterised by a liquidity index $I_L = 0.10$, additional tests of strength parameters were performed on saturated samples. After saturation the liquidity index I_L decreased to $I_L = 0.37$, the value of the internal friction angle ϕ fell from 19° to 13° and cohesion decreased from 32 to 20 kPa. With the additional contribution of non-dispersed excessive water pressure below the geotextile layer the obtained stability coefficient of the flat slip line was lower than $F = 1.0$.

Figure 7.
Cross-section of the slope after destruction
