STRUCTURAL FAULTS OF HISTORIC ST. GEORGE'S CHURCH IN GLIWICE OSTROPA – ANALYSIS AND STRENGTHENING METHODS

Jacek HULIMKA*

Abstract

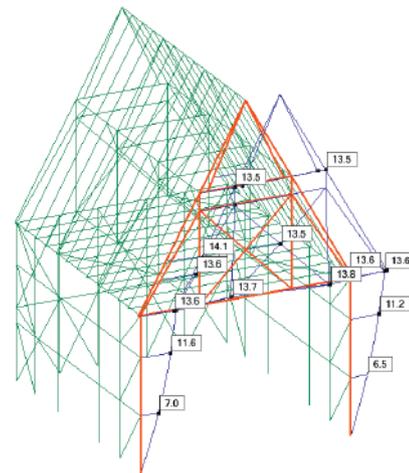
From computational point of view, system of angle braces employed in the original design, in which relocations of joints in the top beam of the extreme load bearing system reached the value of 0.136 m (Fig. 4), turned out to be the worst. It is unacceptable solution as it leads to basing new structure posts on original sidewalls, and at the same time to loading walls with horizontal forces. Distance between posts and original wall does not exceed 0.10 m and the contractor left installation wedges causing transfer of forces from the posts as concentrated, acting on individual beams of ring beam wall.

Figure 4.
Displacements extreme transverse system in the original structure

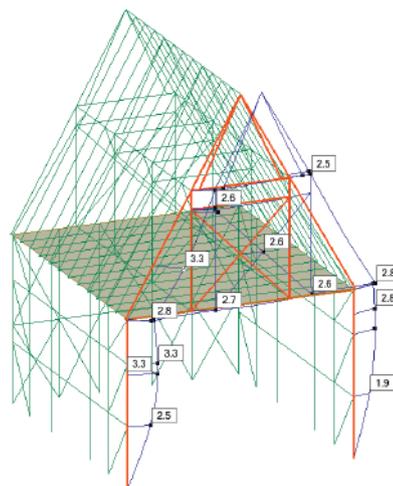
Use of ideal membrane on the floor plane level over the nave results in limited relocations of joints up to the value under 0.03 m (Fig. 5), safe for the original structure. Simultaneous use of membrane and braces practically does not change this value.

Figure 5.
Displacements extreme transverse system in the original structure

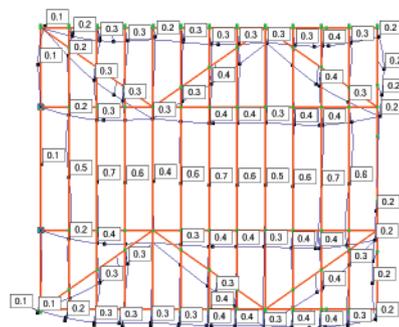
The best results were obtained in case of anchorage of intermediate joints of the eastern girder in the ring beam of presbytery western wall – relocations of top beams joints do not exceed then the value of 0.004 m (Fig. 6).

Figure 6.
Displacements of joints on the floor plane, with anchorage of extreme joints in the ring beam of presbytery wall

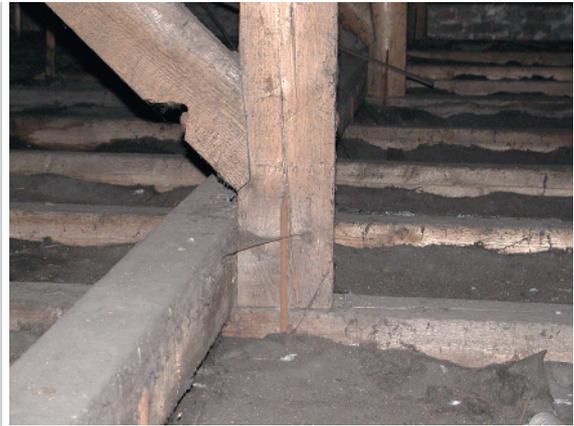
- lack of braces designed in the floor plane,
- improper connection of king posts with stretcher – steel connection clip was replaced with clamp of relatively small load capacity causing wood cracking (Fig. 7),
- improper suspension of the intermediate floor beams – bolts were replaced with clamps as above (Fig. 8),
- lack of local bracing of joints.

Figure 7.
Improper connection of the truss roof king post with stretcher – with the use of the clamp

- additional anchorage of the ground beams to foundations as well as posts to ground beams,
- proper joining of stretchers with king posts (roof beams) and intermediate floor beams with longitudinal beams,
- strengthening of all joints showing features of rigidity or load bearing capacity loss,
- tightening of the floor plate (membrane) or anchorage of extreme girder joints to reinforced concrete ring beam over the presbytery western wall.

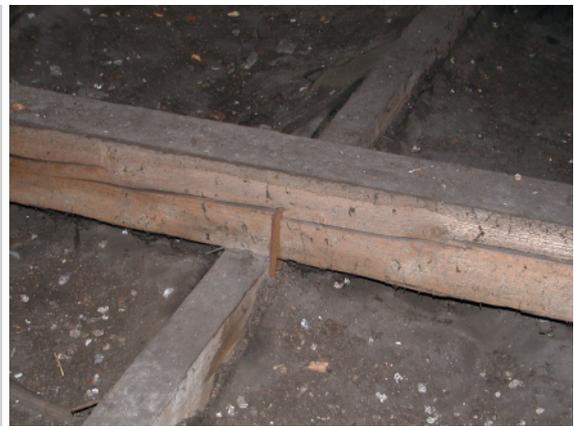
Figure 8.
Improper suspension of the intermediate floor beam – with the use of the clamp

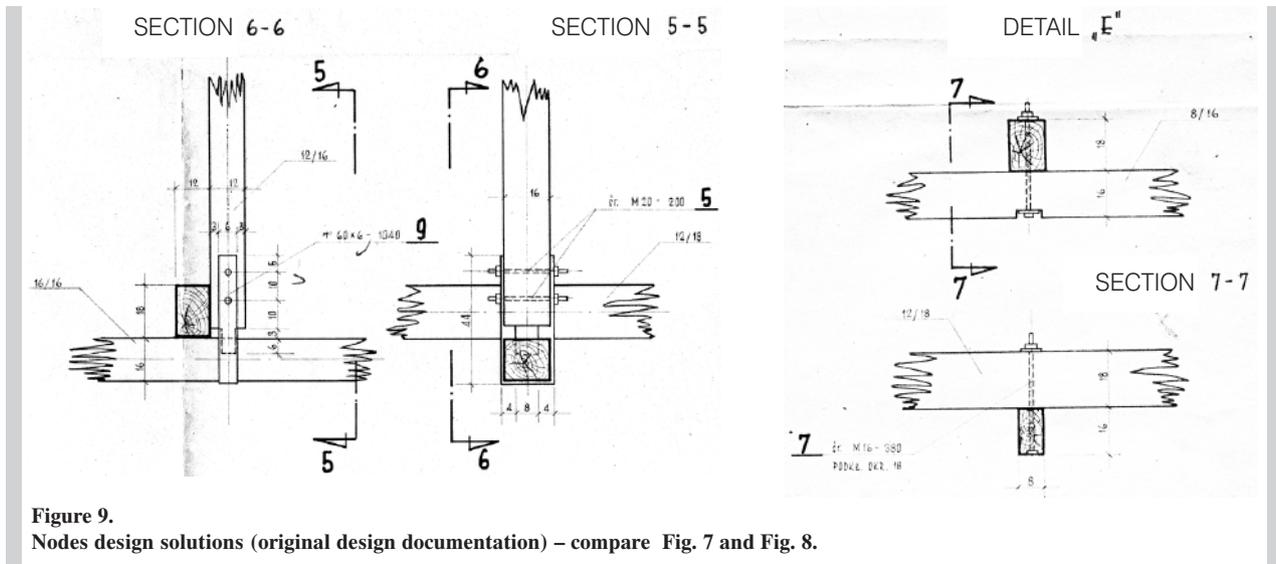
In practice, it turned out that all roof structural elements mentioned above (except for stiffening of floor shield) were solved properly in the original structure design of dated 1965. Hence, detailed recommendations for construction include drawings directly taken from that design (scanned fragments have been presented in Fig. 9). Floor stiffening was designed in the

Figure 9.
Nodes design solutions (original design documentation) – compare Fig. 7 and Fig. 8.

form of horizontal shield made of OSB plates fixed to the ceiling beams as well as additional transverse beams. Moreover, it was assumed that nodes in walls frame structure would be strengthened with the use of overlays made of flat bars fixed with screws.

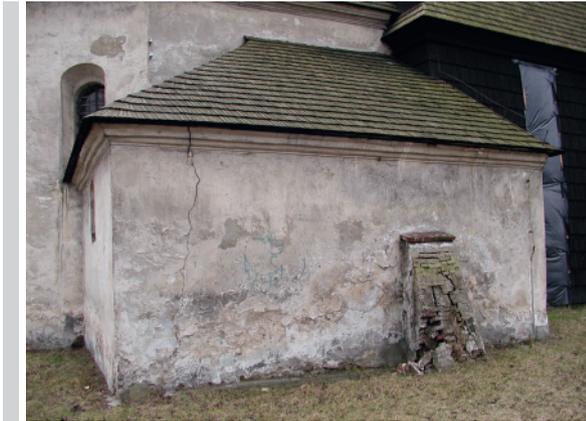
Even cursory inspection of available elements of sacristy structure reveals its before-damage state actually threatening with collapse of part of walls and vaults. Numerous cracks appear within the whole masonry structure covering practically all walls and substantial part of the vaults. The most significant ones have been presented in the following photos (Fig. 10-13). Moreover Fig. 10 shows practically whole damage to the slope supporting northern wall of sacristy.

Damages within brick slopes were caused by intensive dampness and frost penetration.

Figure 10.
View of the sacristy northern wall

Damaged parts of the slope require dismantling and reconstruction with simultaneous construction of effective horizontal insulation.

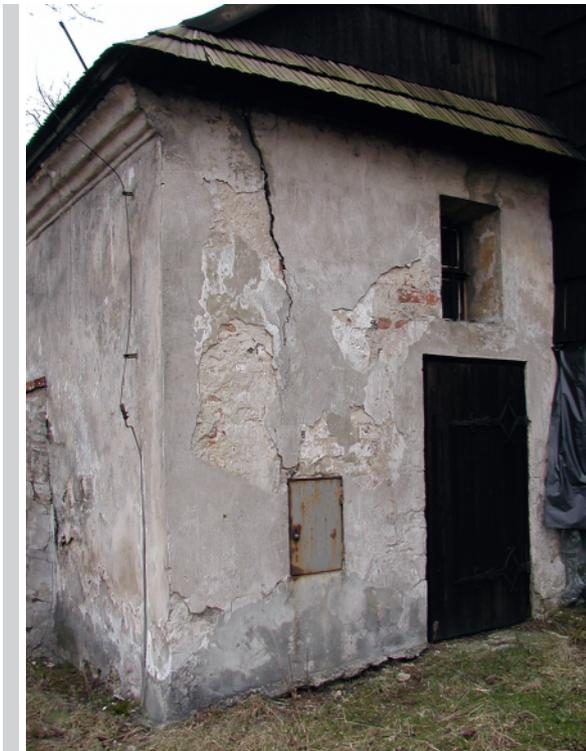
Based on available sources it can be assumed that the most significant cracks within sacristy walls and vaults appeared in the 70's and 80's of the twentieth century as they were not mentioned in the earlier sources. Therefore, observed structural defects appeared right after construction of the above motioned reinforced concrete bands and ring beam over the presbytery. Practically all observed cracks in the sacristy walls and vaults were caused by subgrade deformations resulting from mining exploitation. The nature of cracks shows it; intensive ones in vaults and upper parts of the walls where protection was not provided, and disappearing ones in bottom part of walls secured by reinforced concrete band. Similar type of cracks did not appear in presbytery where strong reinforced concrete ring beam was constructed at the level of rafter framing base.

Figure 11.
View of the sacristy western wall

- cleaning and injection of all cracks with the use of adequately modified fine-grained cement mortars or resin; in case of the biggest cracks local reinforcement of walls is recommended,
- construction of reinforced concrete ring beam or steel stretchers hidden in the top part of walls, capable of carrying tensile forces in case of further sub-grade deformations; such activity is not required if obtained data proves lack of such danger.

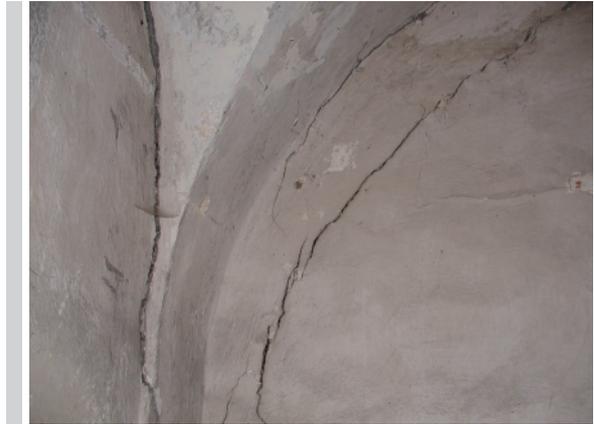
Figure 12.
Cracks in the sacristy north-east corner

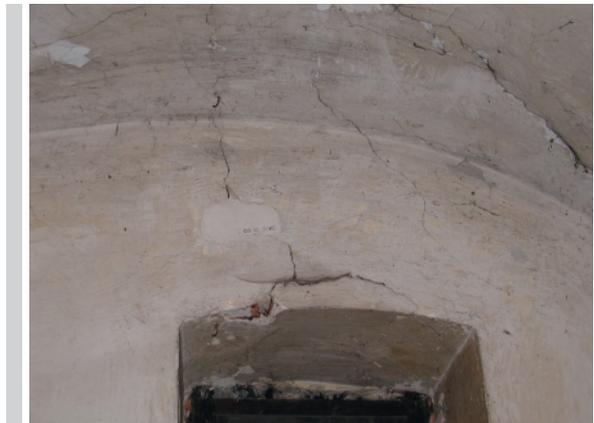
Figure 13.
Window head in the sacristy western wall
