## FACADES OF MODERNIZED BUILDINGS – DIFFERENT STRATEGIES, DIFFERENT EFFECTS – CASE STUDIES OF SELECTED PUBLIC UTILITY BUILDINGS

Joanna TYMKIEWICZ \*

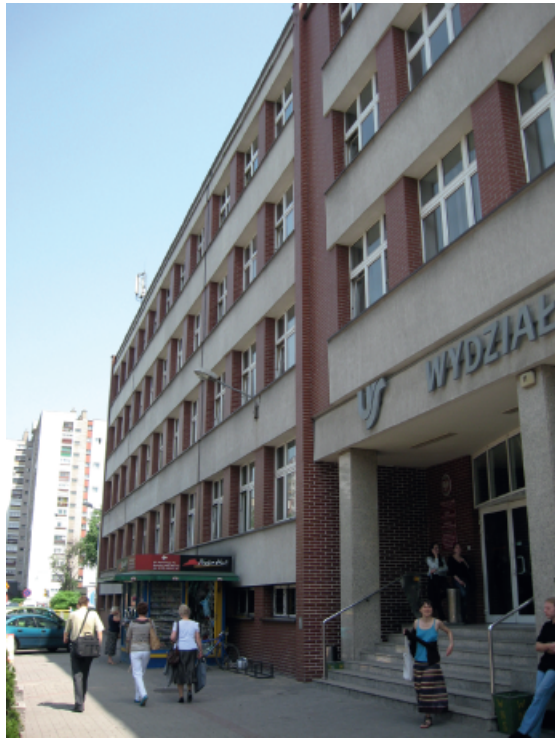
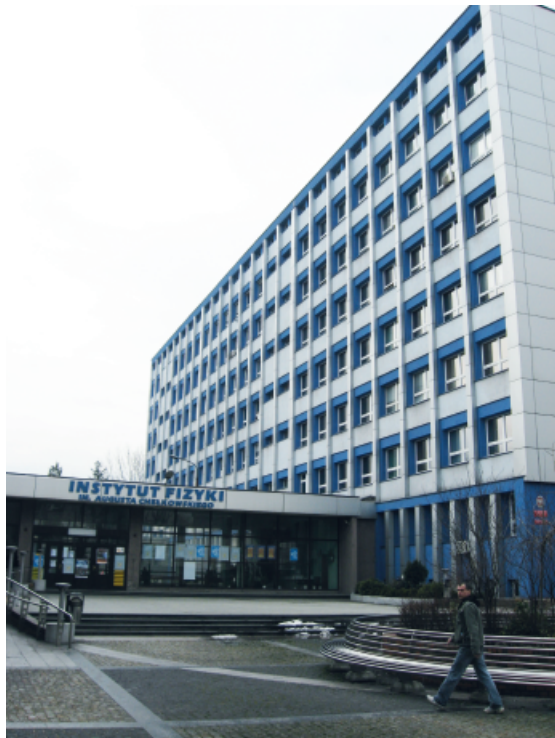
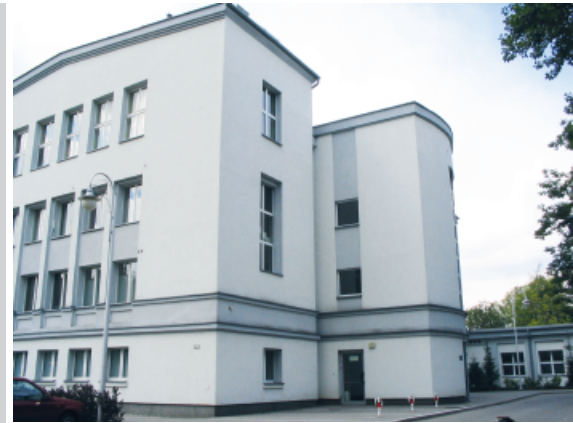
**Figure 1.**  
Faculty of Social Sciences building, University of Silesia in Katowice (photo J. Tymkiewicz)

**Figure 2.**  
Department of Physics building, University of Silesia in Katowice (photo J. Tymkiewicz)

**Figure 3.**  
Management and Social Sciences College building in Tychy (photo J. Tymkiewicz)

ment of windows and doors There are many examples of such procedures in Poland, in old university buildings (Fig. 1-3). Under such circumstances, the interiors of office buildings often receive new equipment including mechanical ventilation or air conditioning.

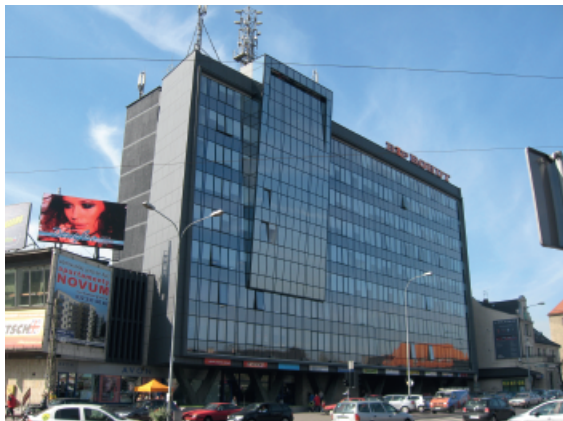
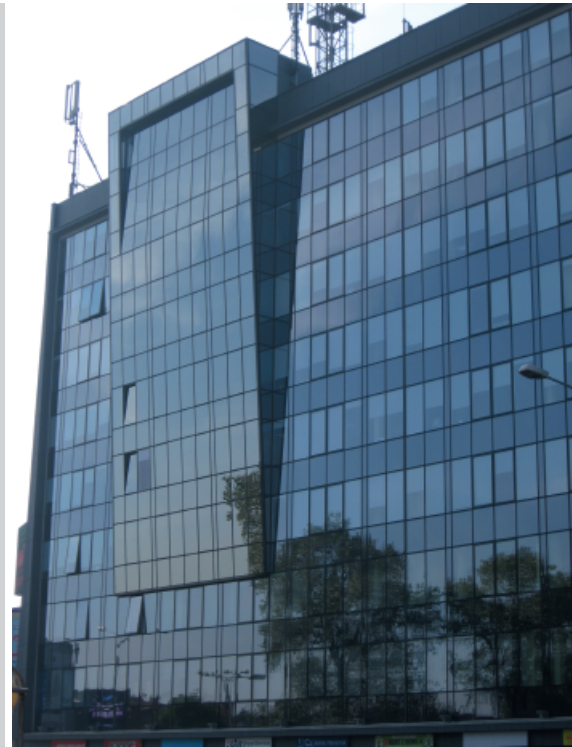
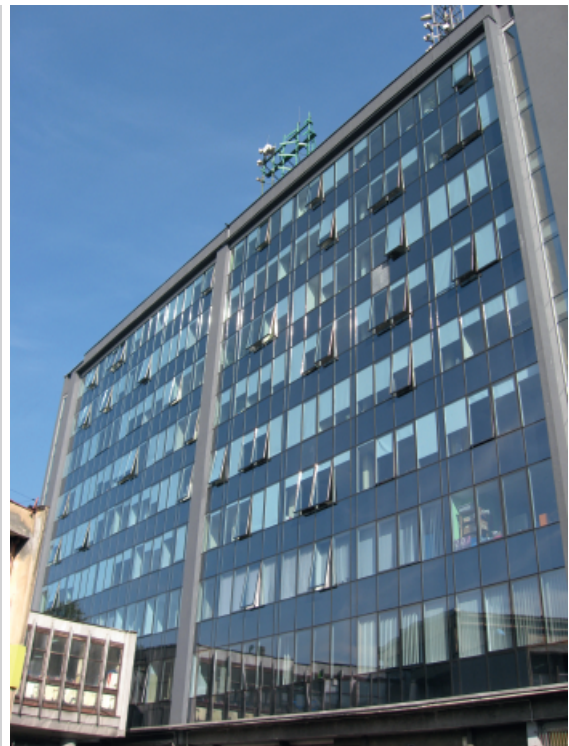
**Figure 4.**  
Replacement of glass facades – “Biprohut” building in Gliwice (photo J. Tymkiewicz)

**Figure 5.**  
The front facade after renovation – “Biprohut” building in Gliwice (photo J. Tymkiewicz)

**Figure 6.**  
The back facade of “Biprohut” building in Gliwice (photo J. Tymkiewicz)

In 2007-2009 the building was subjected to modernization works (design architect *C. Knebloch*) and received a new “skin” in the form of glazed facades, aluminium structure, with two types of glazing – transparent and opaque. In the strip below the windows spandrels were used, thanks to which the facade seems completely glazed (Fig. 4-6). The renewal of the facade was intended to improve the micro-climate of the interiors (air conditioning was planned to be installed), energy-efficiency and aesthetics of the building, as well as to endow it and its owners with a new, modern look.

As far as the microclimate is concerned, one of the problems that occurs in “Biprohut” building is the overheating of the rooms behind the glazed facades in the warm season – despite the use of special type of glass. In the autumn of 2010 the rooms had no air-conditioning yet and the users could still open the windows, which will be impossible after the installation of air-conditioning (there will be special keys to prevent this).

The protection against the sun is provided by blinds that may be individually adjusted, thanks to which the building facade creates the impression of change and liveliness, although it may seem a bit “messy” – due to various position of the white blinds. Furthermore, completely unfolded blinds eliminate the visual contact with the external environment. On the other hand, the noise reaching the building from the streets around was reduced.

The new window bay highlights the flat facade and makes it look more dynamic; moreover, it serves some specific function – it enlarges the floor area (total: 70 m<sup>2</sup>). In addition, a recreation zone was created at the top floor of the building.

The design of the new facade had to consider the safety issues, as it is possible to open the windows. The glazed surface has the windows that open out from the bottom. In the inclined part of the bay window (4<sup>0</sup>), customized tilt windows were installed, opening inside from the top. Such solution protects the users from falling out of the window.

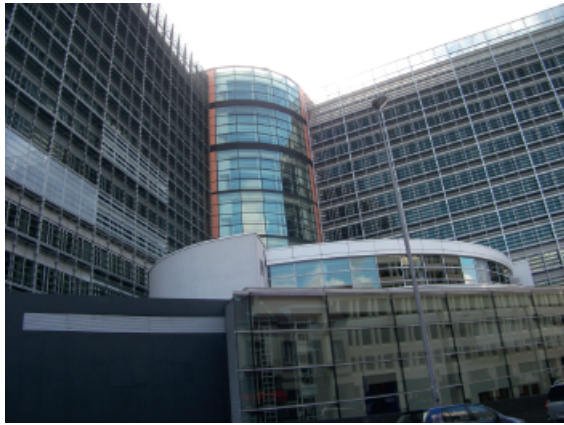
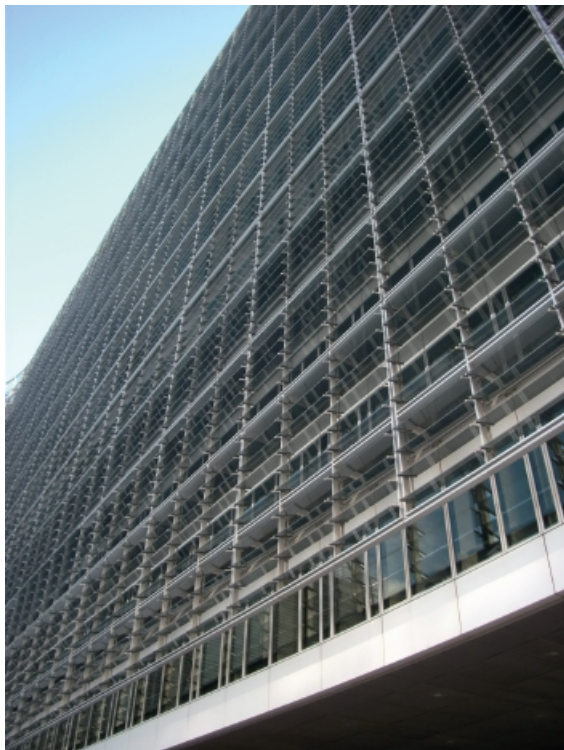
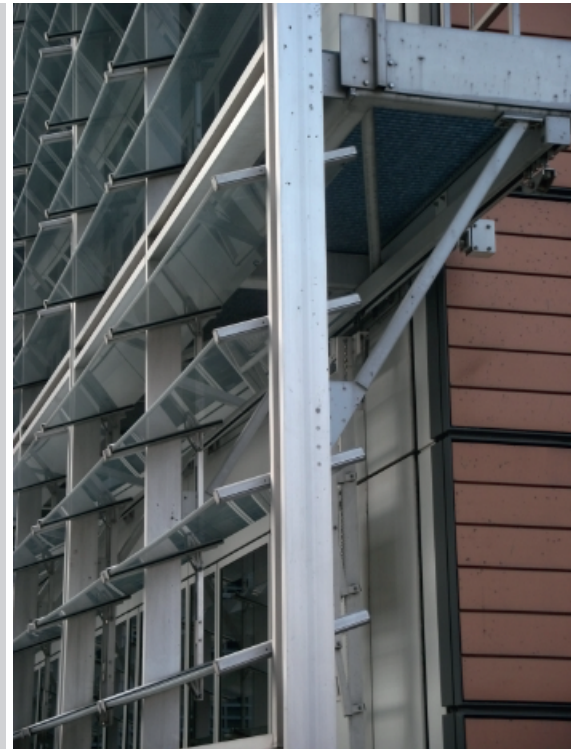
**Figure 7.**  
The headquarters of the European Commission in Brussels after modernization (photo K. Mastej)

**Figure 8.**  
Facade of Berlaymont building in Brussels (photo K. Mastej)

**Figure 9.**  
Details in the facade of Berlaymont building, Brussels (photo K. Mastej)

The building, erected in 1960-69 (the design architects: *L. De Vestel, J. Gilson, and J. and A. Polak*), was given the form of a cruciform with four wings and fourteen above-ground floors. The renovation and modernization architectural design (authors: *P. Lallemand, S. Beckers and W. Van Campenhout* 1995-2004) assumed shielding the building facade with a double-glazed wall. The external shell consists of movable laminated screen printed glass panels. The panels are divided into autonomous units and are automatically controlled by the BMS, which, thanks to the coupling with the meteorological station, determines their position, depending on the prevailing weather conditions. Moreover, an integrated system of managing the lighting of the building was installed with sensors placed in the rooms, coupled with the system of adjusting the position of the panels in the external building facade to achieve the required lighting intensity on the surface of the workstations – 500lx [10] (Fig. 7-9).

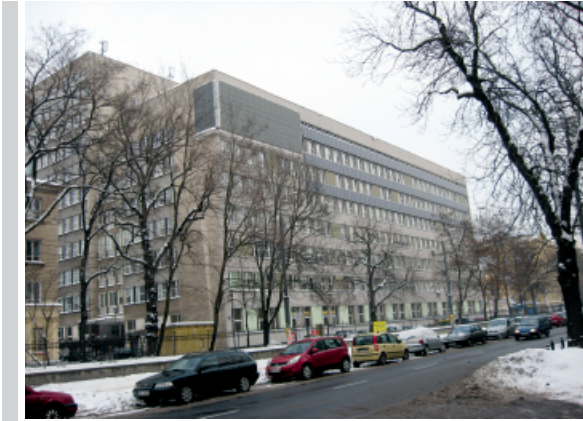
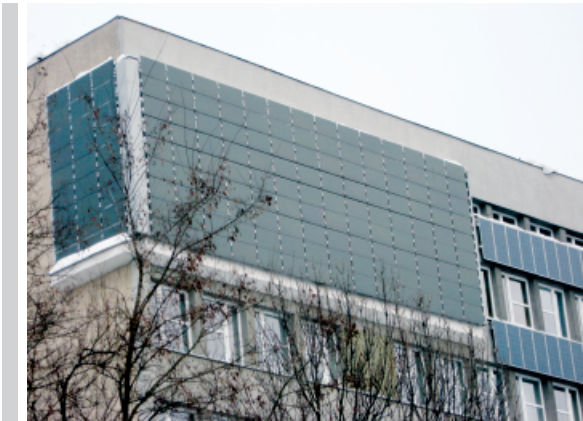
**Figure 10.**  
 The facade of the Environmental Engineering Faculty building, Warsaw University of Technology (photo J. Tymkiewicz)

**Figure 11.**  
 PV modules installed on facade – Environmental Engineering Faculty building in Warsaw (photo J. Tymkiewicz)

The already mentioned European Parliament and Council of Europe's Directive also assumes that, starting with 2018, the demand for energy will have to be substantially covered by renewable sources that generate energy at site or in the nearest vicinity [16]. One of the possible solutions are photovoltaic modules that may be applied in renovated facades. For example, the USA Embassy building in Genève, which is 20 years old, had its facade and roof transformed in 2005 into a specific solar power plant [12]. A Polish example of modernized facades with the use of PV modules is the building of the Faculty of Environmental Engineering, Warsaw University of Technology, which has the photovoltaic modules installed on its facade and on the roof [12] (Fig. 10, 11).

From the economic point of view, such activity is justified, as some of the facade materials are more expensive than the modules themselves. Certainly, the solar panels that constitute the only layer of the facade must comply with all the conditions set forth for the external partitions, including: thermal insulation, durability, air-tightness and mechanical resistance. In view of the thermal insulation and the necessity of cooling the heating up modules, two-skin solutions are applied, in which the inter-facade space between the internal glass skin and the external modules enables the air flow that removes the heat from the modules [13].

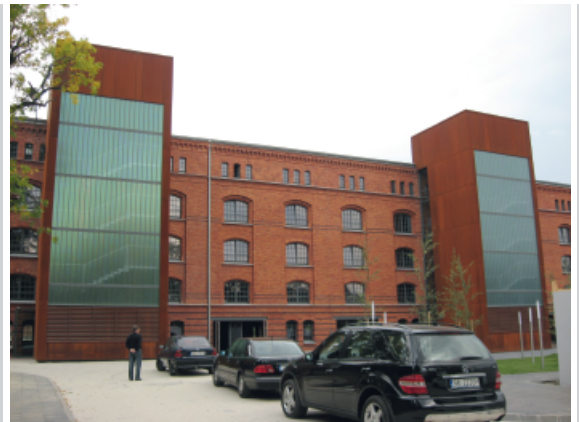
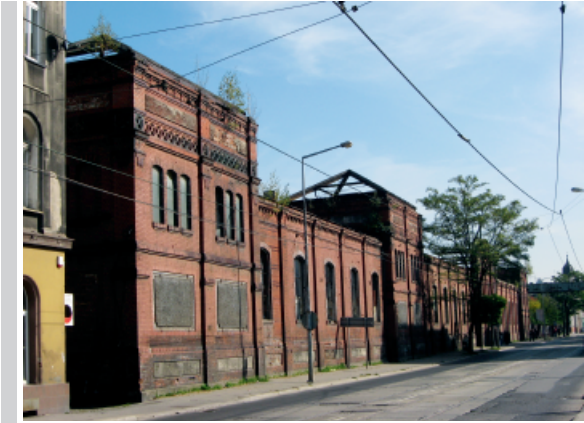
**Figure 12.**  
 The revitalised building of the old granary house in Gliwice – presently housing the lofts designed by Medusa Group (photo J. Tymkiewicz)

**Figure 13.**  
Preparation works for further revitalization – empty “shells” of Gliwice Steel-Works facilities (photo J. Tymkiewicz)

Likewise, in Poland, in the course of the revitalization of post-industrial sites and facilities, numerous projects have been implemented involving the use of old building facades endowed with new functions (Fig. 12, 13).

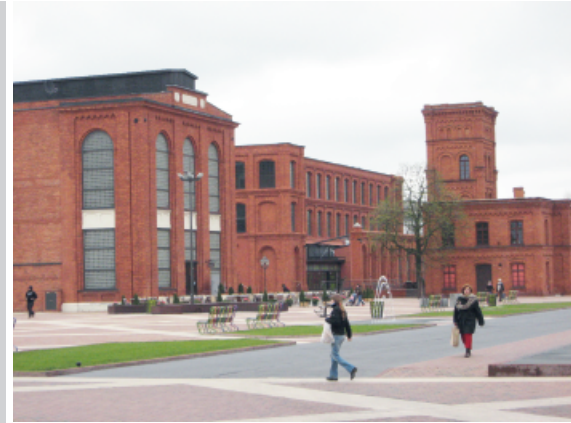
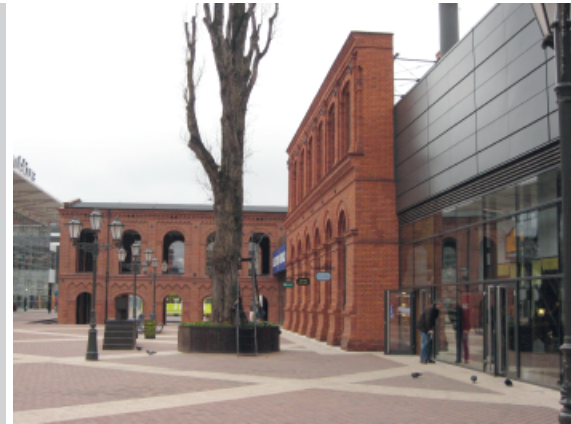
**Figure 14.**  
Post-industrial facilities in Łódź, designed by H. Majewski in the late the 19<sup>th</sup> century (photo J. Tymkiewicz)

**Figure 15.**  
“Manufaktura” shopping mall, leisure and business centre (the modernization design – 2003, implementation – 2006 – Sud Architectes and arch. A. Mrowiec – conceptual design), (photo J. Tymkiewicz)

Such manner of altering the functions of buildings poses some serious problems, which for instance came up in the case of I. Poznański’s factory facilities in Łódź, transformed into “Manufacture” Centre. Originally, the facilities served industrial functions, with fairly constant internal air parameters during the 24 hours. In the early 1990s the facilities were not heated and started to deteriorate year by year [4]. The unprotected elements of the buildings were exposed to the destructive impact of the external environment, including rainwater. The technical condition of the facade “made of dark red brick with highlighted lesenes joined with the frieze and brick cornices” was seriously threatened [3]. The new functions embedded in the old structures evoked changes in the internal and external “environmental context” of the renovated complex. As far as the external space is concerned, the intervention in the urban system led to changes in the local climate, involving the natural lighting, shade, and air flow around the buildings [4]. To secure the durability of the historical factory walls and to prevent their destruction caused by the internal and external environments, simulation analyses were conducted focused on the assessment of the impact of various modernization methods on the condition of the external walls. One of such methods is discussed in detail in D. Heim and S. Krawczyński’ paper, where the authors presented the analysis of the physical and construction problems occurring in post-industrial facilities on the basis of the case study of “Manufaktura” in Łódź, which was the biggest European brown-fields revitalization project and a specific “study field” (Fig. 14-15) [4].

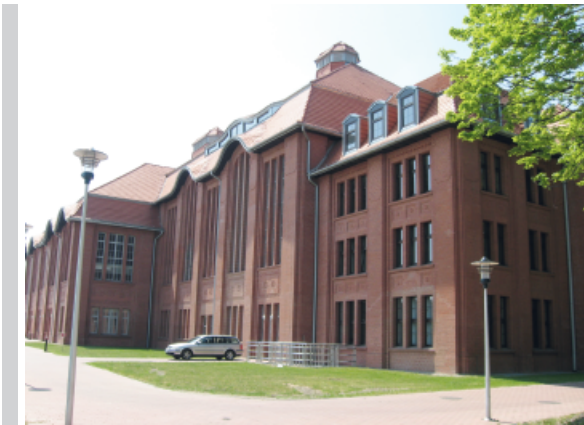
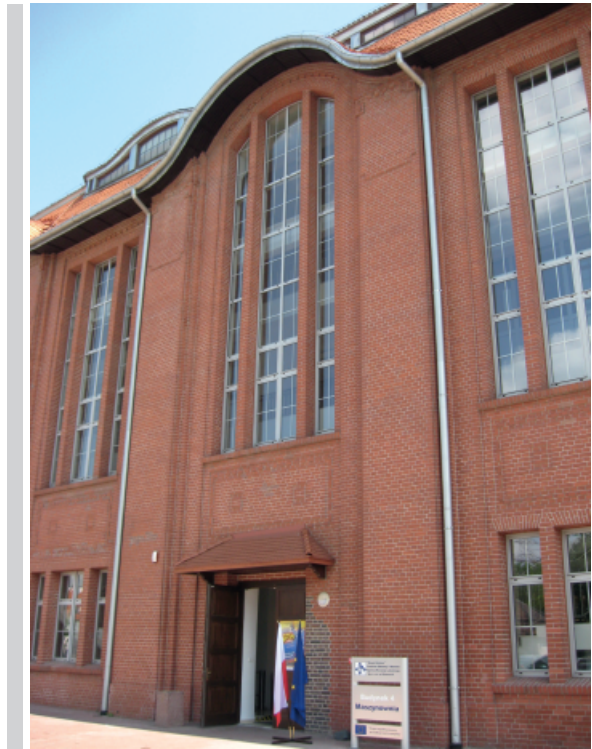
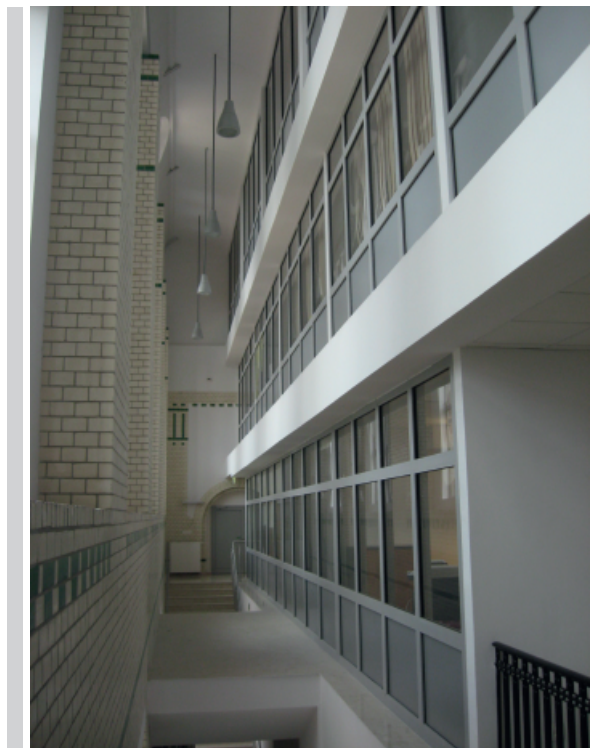
**Figure 16.**  
The old Machine House at the site of the previous coal mine in Gliwice – the back facade (photo J. Tymkiewicz)

**Figure 17.**  
The entrance facade of Machine House building, Gliwice (photo J. Tymkiewicz)

**Figure 18.**  
Interior of Machine House, currently functioning as an office building (photo J. Tymkiewicz)

visiting the post-mining complex in Gliwice. The visit included the round and local inspection of the buildings, interview with the administrator and surveys of the users. From the aesthetic point of view, the buildings are on a very high level. The revitalization project has brought the site of the liquidated coal mine back to life. The problems involved in the old walls were effectively solved and new functions really well-planned [2], [14]. However, one of the problems that has not been properly addressed is the micro-climate of the office facilities arranged in the old Machine House (designed by *G. and E. Zillmann* in the early 20<sup>th</sup> century) (Photographs 16, 18). The implemented concept of “a building inside the building” (Photograph 17), i.e. an independently glazed structure inserted into the single-space interiors of the old facility (foredesigns for the adjustment of the post-mining buildings to serve new functions: ArKuS design and consultation office, the construction project: Mexem, 2004/2005). The combination of various issues – starting with the assumed ventilation concept, through the ensuing decision about the modules of the glazed internal partition that cannot be opened, up to the so called “human factor”, have all resulted in the users’ complaints about excess heat in the building and their total incomprehension of the fact that the simplest solution, involving opening the windows and airing the overheated interiors, is impossible.
