ANALYSIS OF THE IMPACT OF LONGWALL MINING ON SACRED HISTORIC BUILDING

Lucyna FLORKOWSKA*

Abstract

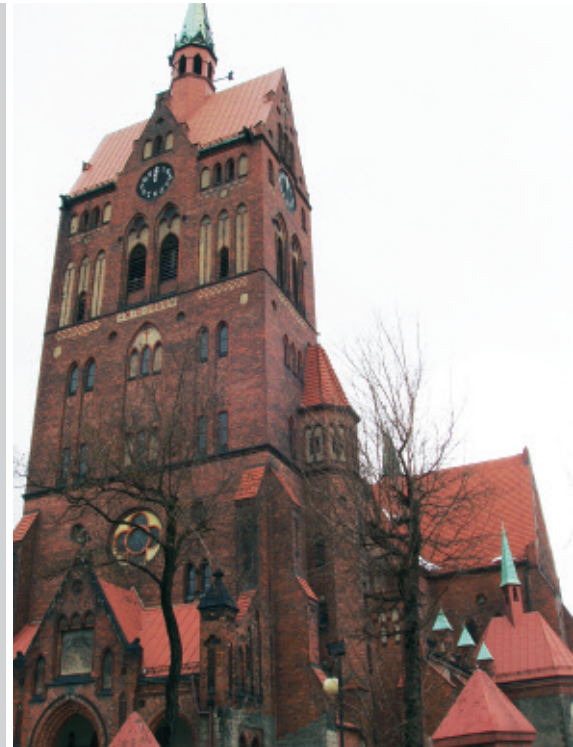
Saint Wawrzyniec and Antoni's church (Fig. 1) is located in Nowary St. in the Wirek district of Ruda Śląska. Its origins clock back to the beginning of the XX century. It was completed by 1909. The church is a typical for that period Neo-Gothic structure. It has three large-bodied naves, whose dimensions are approx. 66×60 m.

Figure 1.
Saint Wawrzyniec and Antoni's church in Ruda Śląska – Wirek. South-east view

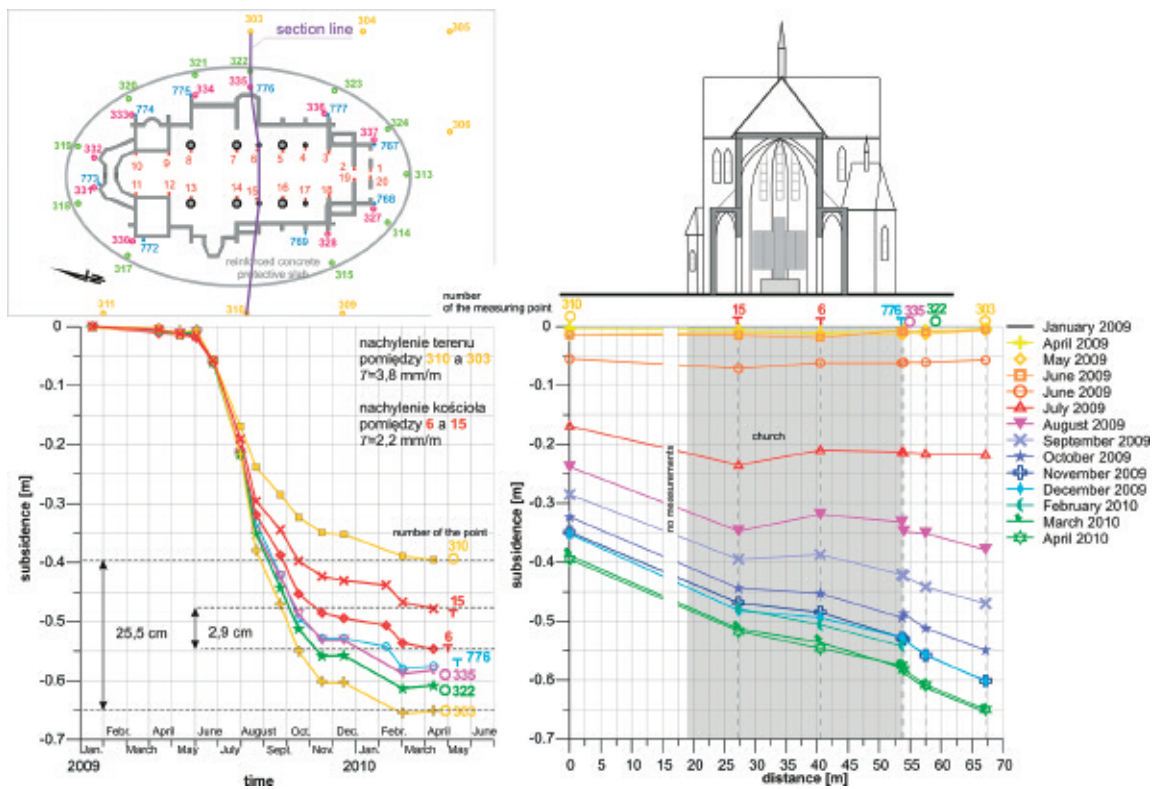
Figure 11. Subsidence measurements for the 310-303 cross-section

Fig. 11 illustrates the subsiding process of benchmarks arranged perpendicularly to the building's lon-

gitudinal axis. Consequently those points created a cross-section. Within it, the highest subsidence differences were measured. They were:

- surface (between points 303-310) – 0.25 m,
- church (between points 15-6) – 0.03 cm.

Thus, the surface gradient between point 303-310 was 3.8 mm/m, whereas the body of the church has permanently tilted east between points 6-15 by 2.2 mm/m. Plot of the “subsidence – distance” relation illustrates how the body of the building leaned concurrently with advancing longwall face. Initially, the body tilted slightly west (July, August and September 2009). Then the building straightened up and once the longwall face came past it, started to lean east. The highest subsidence of 65 cm was registered at the 303 point.

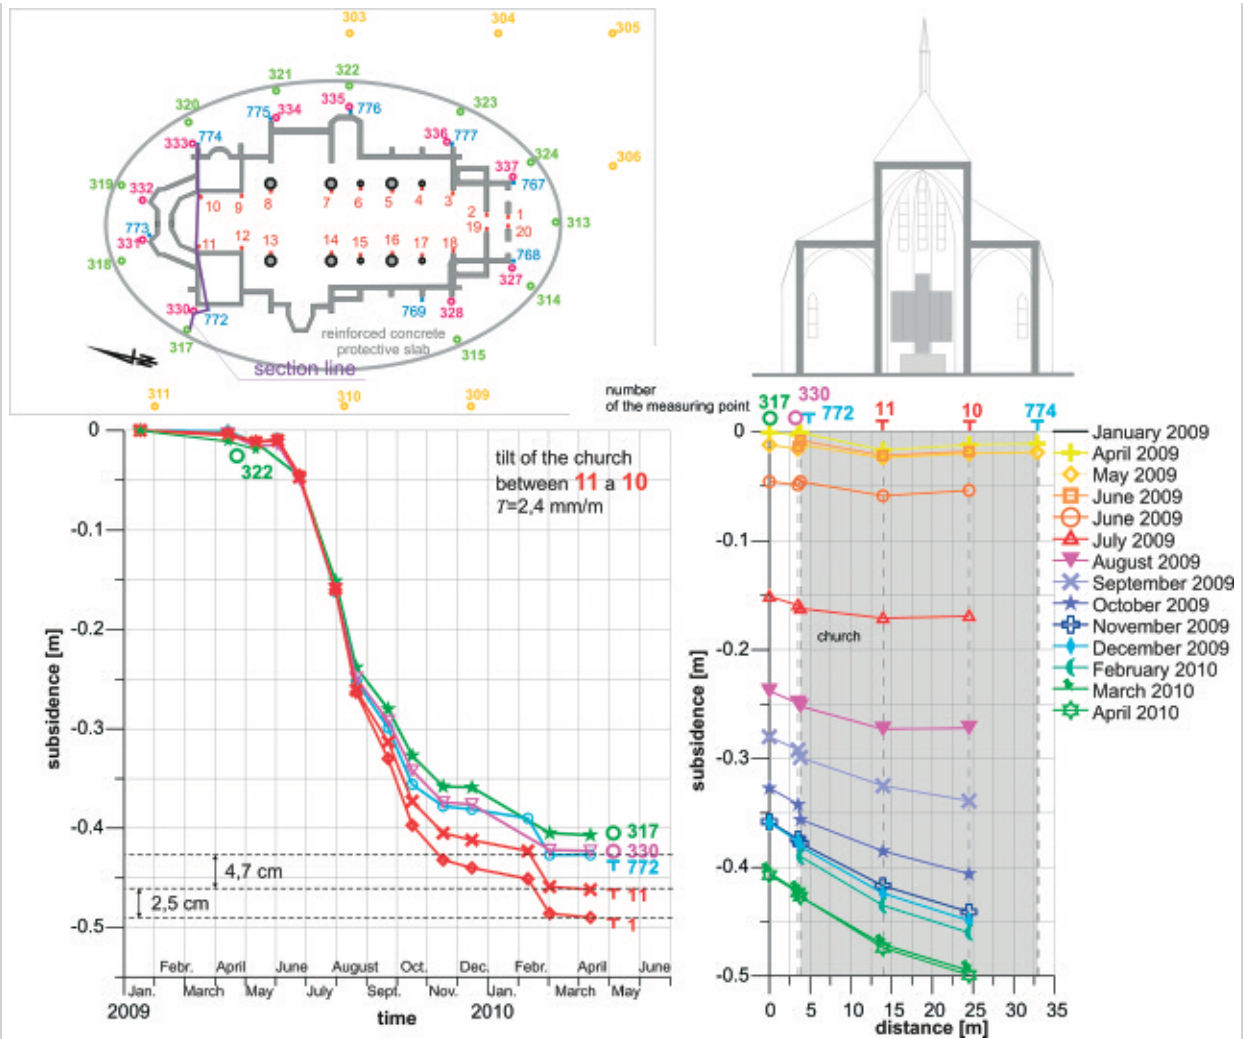
Figure 12. Subsidence measurements for the 317-774 cross-section

Fig. 12 presents corresponding subsidence charts for the points creating the cross-section passing through the presbytery. Similar tilt of the body of the church was registered in that cross-section. Between points 10-11 it was 2.5 mm/m.

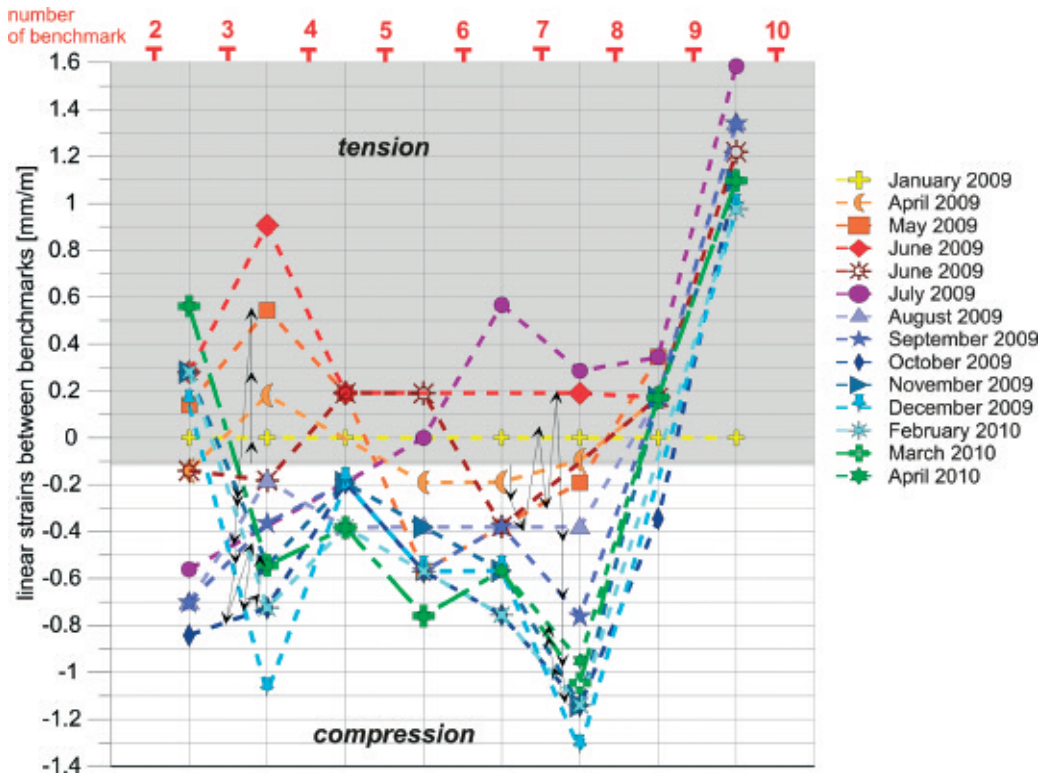
Figure 13. Linear strain between measuring points over time

Figures 13 and 14 illustrate strains measurements taken from baselines located between benchmarks inside the church (see Fig. 9). Figure 12 reveals how

strains between main nave pillars shifted from small positive reactions towards the negative reactions. By comparing it with chart No. 10 it is evident, that negative strains appearing within the main nave is related to the curvature which has appeared in that area and started to generate compressive stress. Positive strains between benchmarks 9-10 confirm, the sector where the presbytery is behaves differently. Strains over time illustrated in Fig. 13 indicate that 9-10 strains line differs from measurements taken at other baselines.

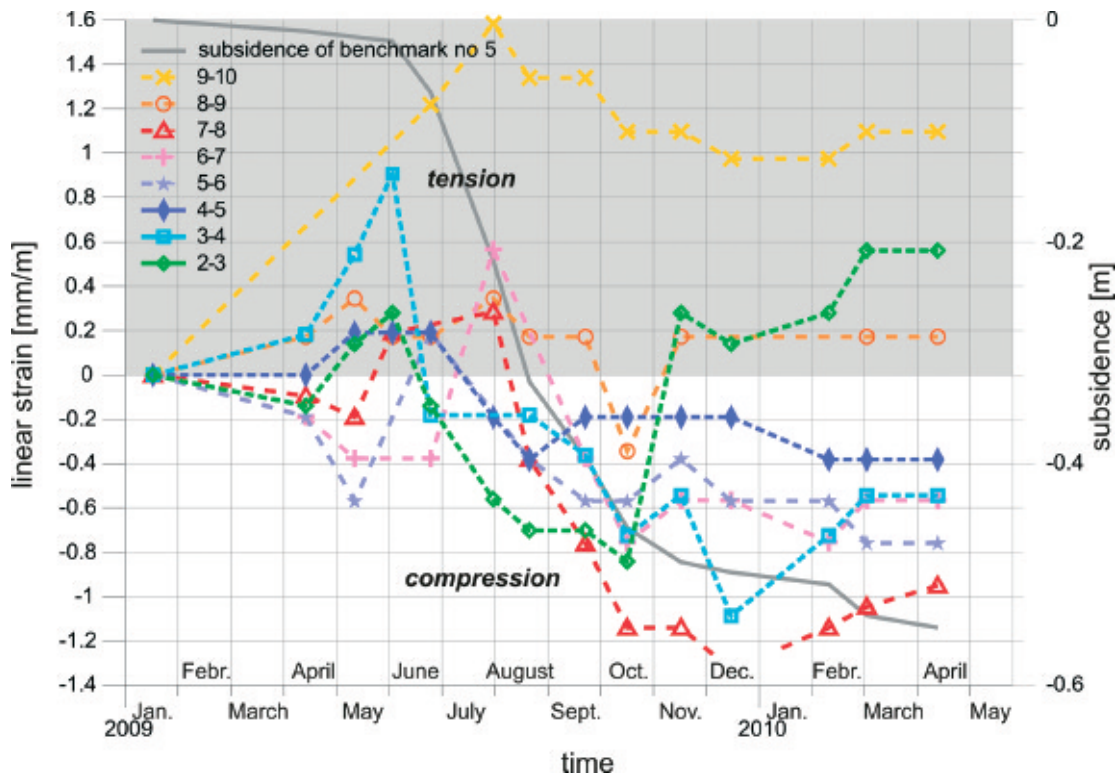
Figure 14. Linear strain over time between measuring points located along the building's longitudinal axis

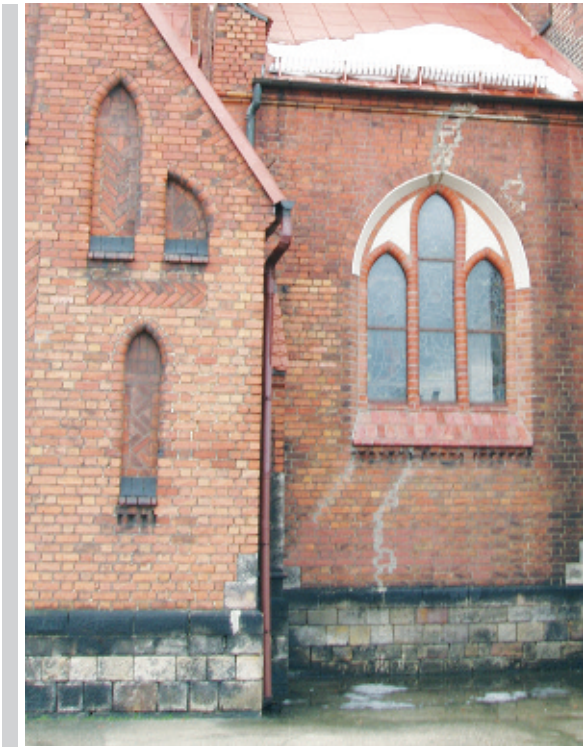
Figure 15.
Cracked protective plate and church's exterior wall

Despite protection against mining damage, due to mining influences the building sustained damage and became deformed. Already before mining of the 133 longwall commenced, the church's protective slab became damaged to a certain extent. Fig. 15 i 16 shows damage in the church's exterior walls.

In 2010, after finishing of excavation of 133 longwall, the building underwent a heavy repair, which involved fixing all damage and renovation. There are no mining plans in the foreseeable future for the area.

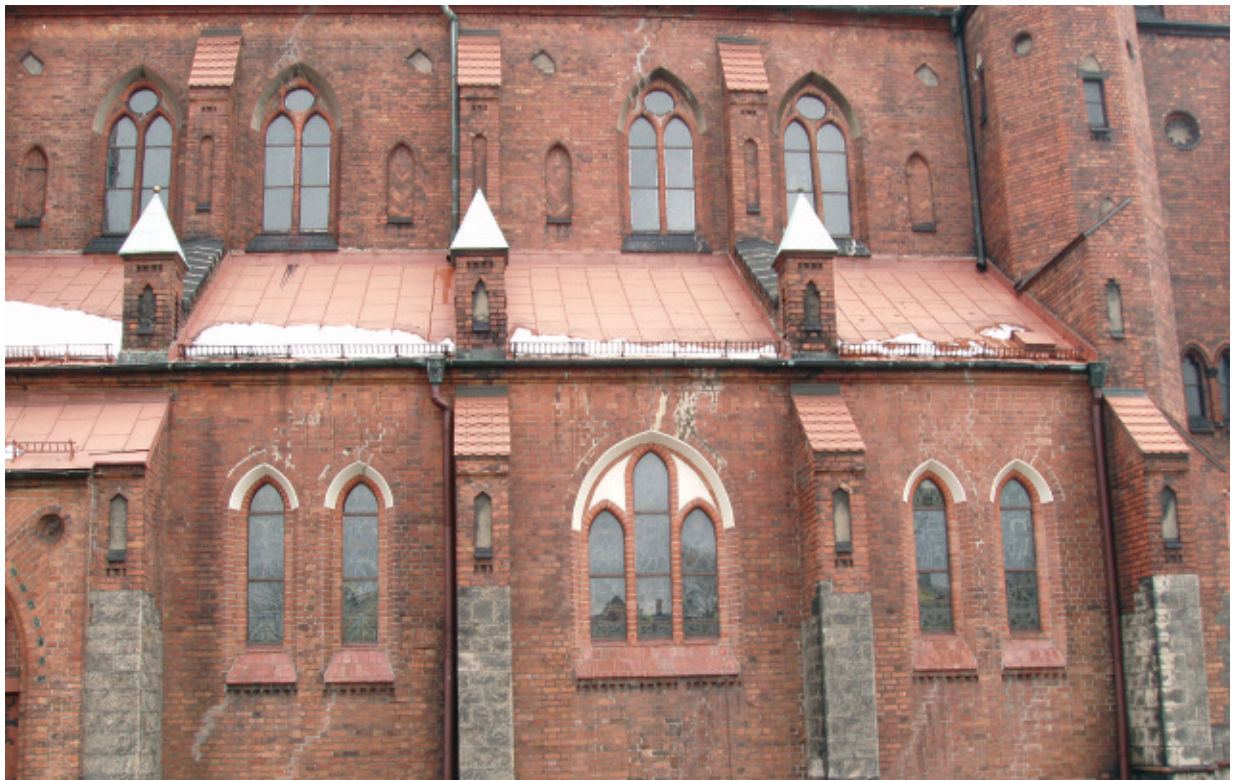
Figure 16.
Damage to church's exterior walls
