POST OCCUPANCY EVALUATION OF THE LIBRARY BUILDING: DIYARBAKIR PROF. DR. FUAT SEZGIN PROVINCIAL PUBLIC LIBRARY

In this study, the suitability of the use of Diyarbakir Professor Doctor Fuat Sezgin Provincial Public Library building as a library building is investigated. The study aims to determine the characteristics of the library building and to offer design and construction suggestions to increase user satisfaction. One of the most important methods of determining the quality of a building is to consult the opinions of the real users of the building. This method can also be defined as post-occupancy evaluation (POE) [9]. The

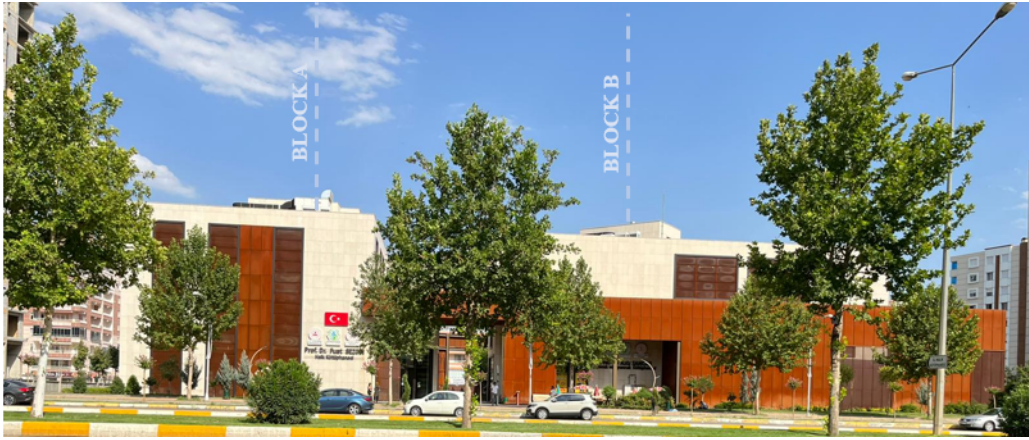
Figure 2.
Diyarbakir Prof. Dr. Fuat Sezgin provincial public library (Photos by the authors)

Prof. Dr. Fuat Sezgin Provincial Public Library (Block A) was opened in 2020 and has a capacity of 210 people. Prof. Dr. Aziz Sancar, Toy and Children's Library (Block B) is not yet in use (Figure 2).

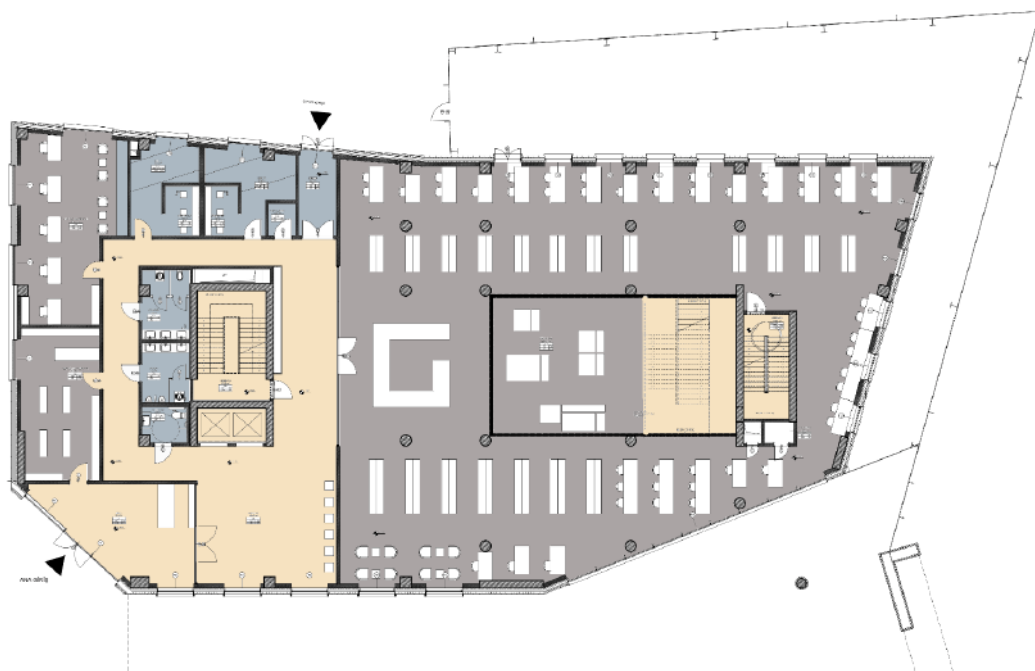
Figure 3.
Library floor plans (Elaborated by the authors from the archive of Kayapınar Municipality of the Republic of Turkey)

The rectangular building was designed with a gallery space in its centre. The building has a total of 4 floors: basement + ground floor + first floor + second floor. The ground floor, first floor and second floor are actively used by users. The basement floor is not included in the study as it is a private and not yet completed space. (Figure 3).

Ground floor plan

Library, Male/Female/Disabled Wc Male/Female Masjid, Librarian Rooms Souvenir shop

First-floor plan

Library, Executive Offices, Workshops, Officer's Room Store, Male/Female/Disabled Wc, Technical Room, Horizontal/Vertical Circulation

Second floor plan

Meeting Hall, Store, Male/Female/Disabled WC, Education Classes, Music Rooms, Visual and Audio Resource Utilization room, Group Workspaces, Horizontal/Vertical Circulation

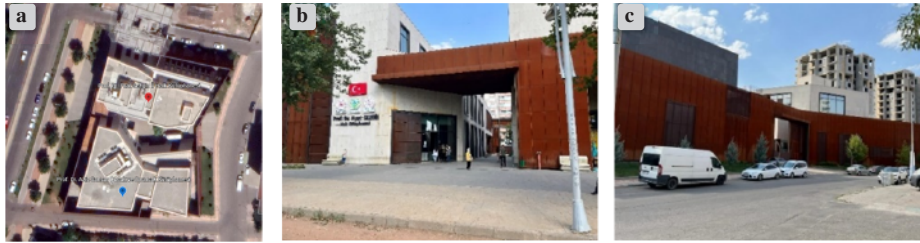
Figure 4.

a) Building form, b) building main entrance, c) building rear entry (Photos by the authors)

The form of the building is a segmented rectangle. It can be said that this building form is generally liked by users (77%). The courtyard between the two library buildings was designed as a gateway to connect the east (327th Street) and west (Mahabbad Boulevard). However, the fact that the rear entrance on the east façade is closed prevents these passages as well as consumes the perception of the rear entrance to a large extent (Figure 4). In the question asked about the perception of the building entrance, an average of 78% was positive. However, in face-to-face interviews, it was determined that the vast majority of users answered without being sure and thinking about the perceptibility of the main entrance. (Figure 4). This shows that the use of the building is as important as the design.

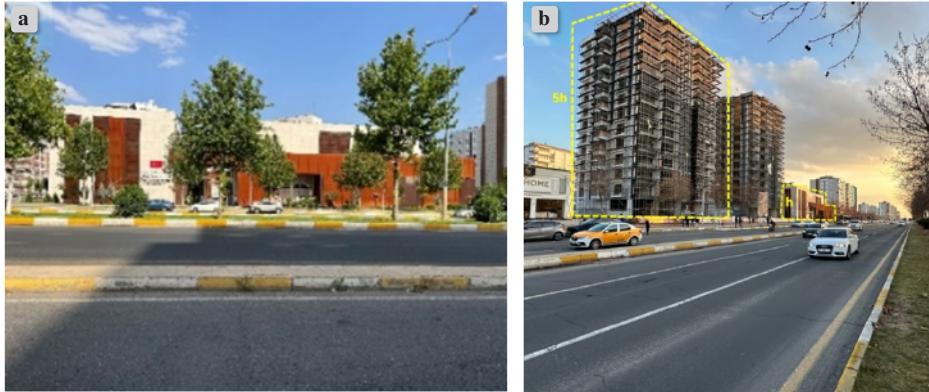
Figure 5.

a) Building design, b) close environment (Photos by the authors)

In the question in which the suitability with the built close environment was investigated, it was determined that the satisfaction rate was quite insufficient at 67.7%. As a result of the field study, it was determined that the average number of floors of the buildings around the library building is 12, and the library building has 2 floors (Figure 5 Building design and close environment). It seems that the results of the field study and the survey are in agreement.

The fact that the library building is at a low level compared to its immediate surroundings negatively

affects its visibility and visual suitability with other buildings. These results show that not enough attention is paid to the immediate environment in the design of the library building.

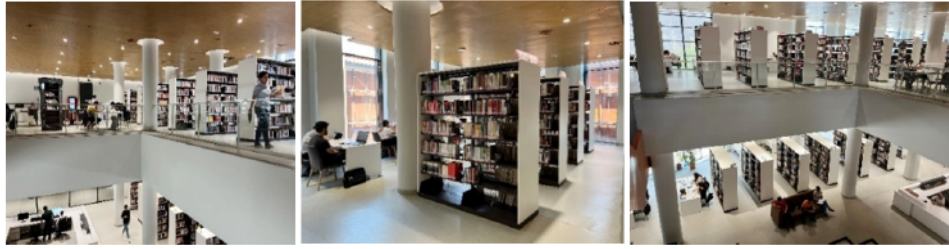
Figure 9.
Interior appearance (Photos by the authors)

User satisfaction (73%) from personal workspaces is slightly above the threshold.. Satisfaction is also slightly above in the parameters of interior (space) design (72.59%), warning and direction signs inside the building (70.7%), and collaboration (65.5%). Co-working space satisfaction, on the other hand, received the lowest satisfaction value. The speech and movements of the users adversely affect their attention and concentration in common working spaces (Table 4, Figure 9).

In general, indoor working environment efficiency is considered sufficient. However, the value of other interior features, especially the co-working space, needs to be increased. Because the first area where students are directly exposed to the image and use while working is the interior.

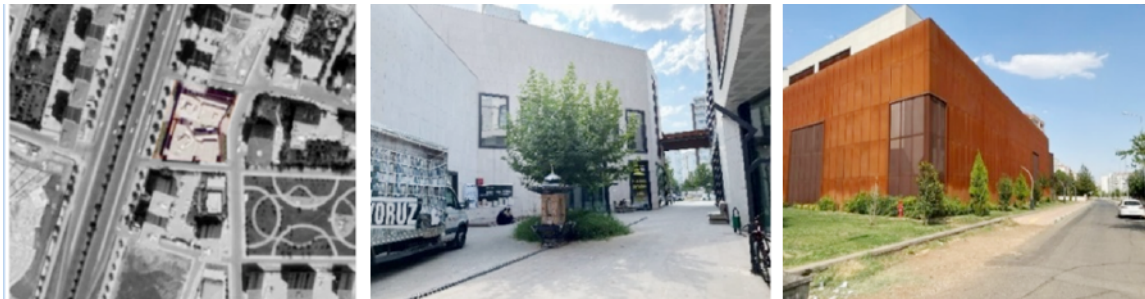
As a result of the field study, it was determined that the building was built with a drawing distance of 10 m from the west facade and 5 m from the other facades. The building occupies the majority of the parcel on which it was built, leaving very little space for landscape elements and socializing areas (Figure 10).

Figure 10.
layout of the building on the parcel, courtyard landscaping and facade cladding material (Photos by the authors)

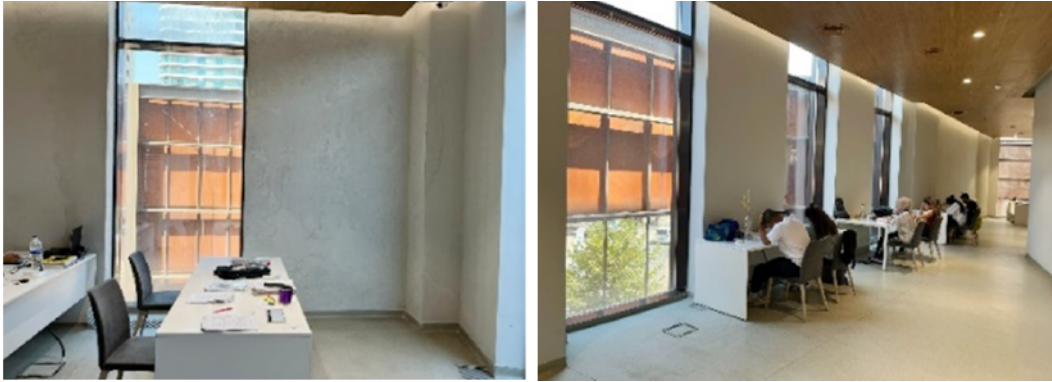
It has been determined that there is a significant dissatisfaction with the natural ventilation (65.92%) and general ventilation system (69.25%). As a result of face-to-face interviews and fieldwork, it was determined that the lack of natural ventilation in the building was the main reason for this. (building windows are fixed and cannot be opened) (Figure 11). Airless and smelly places are harmful to human health. In addition, it reduces their working and perception performance [37]. Considering that the users of the

Figure 11.
Fixed windows (Photos by the authors)

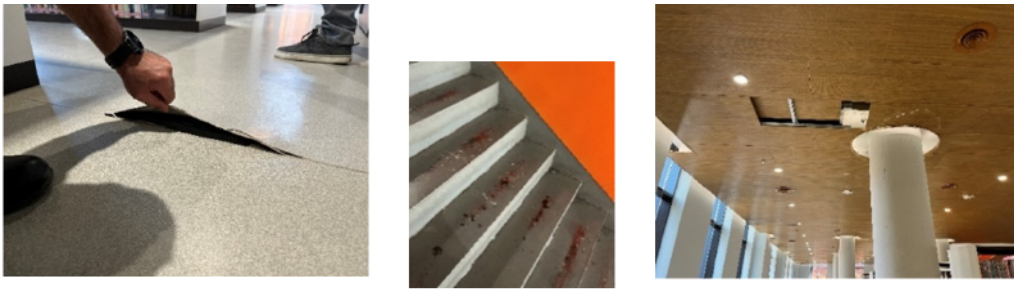
As a result of face-to-face interviews and fieldwork, the reasons for the dissatisfaction with the flooring; it has been determined that the joints are not well welded, noise from the floor and rapid deformation of the materials (Figure 12).

As a result of face-to-face interviews, it was determined that the reason for the dissatisfaction with the ceiling covering was that the parts that fell due to water intake could not be reinstalled and the plumbing was visible. The fact that the level of satisfaction is very low in terms of the measures taken against

Figure 12.
Deformed floor covering material, deformed step, and deformed ceiling covering material (Photos by the authors)

rain in the building supports this situation. As a result of the field study, it was determined that there was significant water infiltration not only on the ceiling but also on the walls. These results show that more attention should be paid to workmanship and material selection.
