## SCALE OF RESISTANCE OF BUILDINGS TO MINING INFLUENCES – APPLICABILITY ASSESMENT THROUGH A CASE STUDY

This paper presents a case study of the impact of continuous deformations and rock mass tremors on a single-family building, typical of Upper Silesia. In the areas subjected to the influence of ground deformation, a point method for assessing the resistance of buildings to these influences has been developed by the Central Mining Institute. As part of this method, the geometric parameters, structure, materials and technical condition of the facility, as well as the ground on which the building is located, are taken into account. A case study considers a building being simultaneously subjected to continuous deformations and mining tremors. The object's resistance is assessed according to the point method and its technical condition is assessed after revealing the influence of ground deformation. This is used to assess the validity of the point method for the building. On the basis of the analyses of the state of deformation and the impact of tremors, conclusions are drawn regarding the need to make changes to the scale used to assess the category of resistance of buildings to the

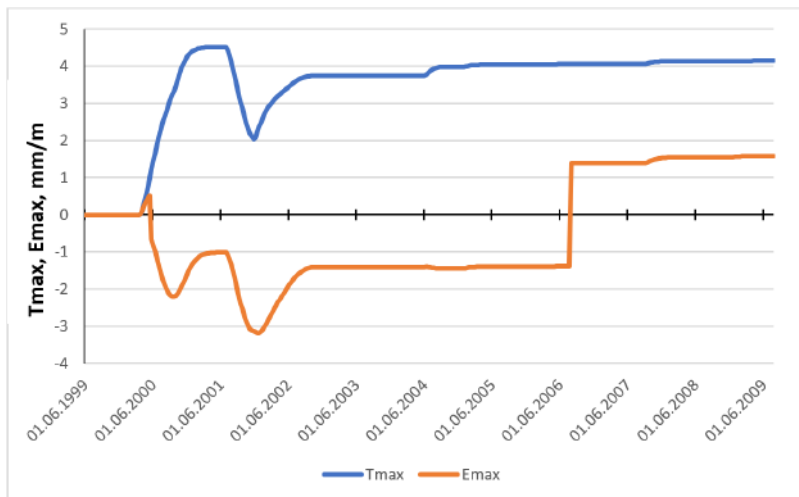
**Figure 3.**  
Graph of the calculated maximum slope ( $T_{max}$ ) and maximum horizontal strain ( $E_{max}$ ) in relation to time according to Knothe's theory

The calculations were carried out using the DEFK-Win program developed by Ścigała [27]. The progress of exploitation fronts was simulated with the assumption of immediate disclosure of influences. Fig. 2 shows the function graph of the subsidence and Fig. 3 shows the maximum slope and the maximum horizontal strain.

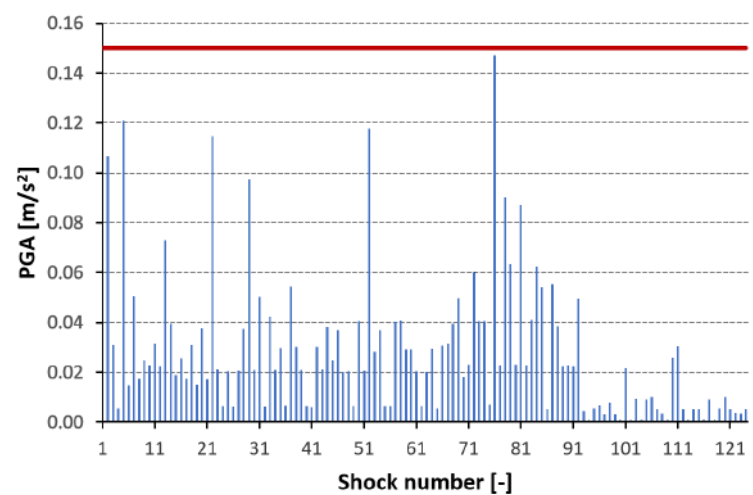
Figure 5.  
Calculated PGA values at the property site according to Eq. (2)

Based on Eqs. (2) and (3), the  $PGA$  and  $PGV$  values were calculated for all shocks from 2018 at the site of the building's foundation. The calculation results are shown in Figs. 4 and 5.

In both figures, a brown horizontal line marks the border of the 0 and I intensity degree. This boundary separates the degrees 0 and I, regardless of the duration of the intense phase of vibrations. Figs 4 and 5 show that all of the shocks shown can be classified according to  $PGV$  and  $PGA$  values at a 0 degree. Thus, according to the results of the calculations, the shocks should have no effect on the building.

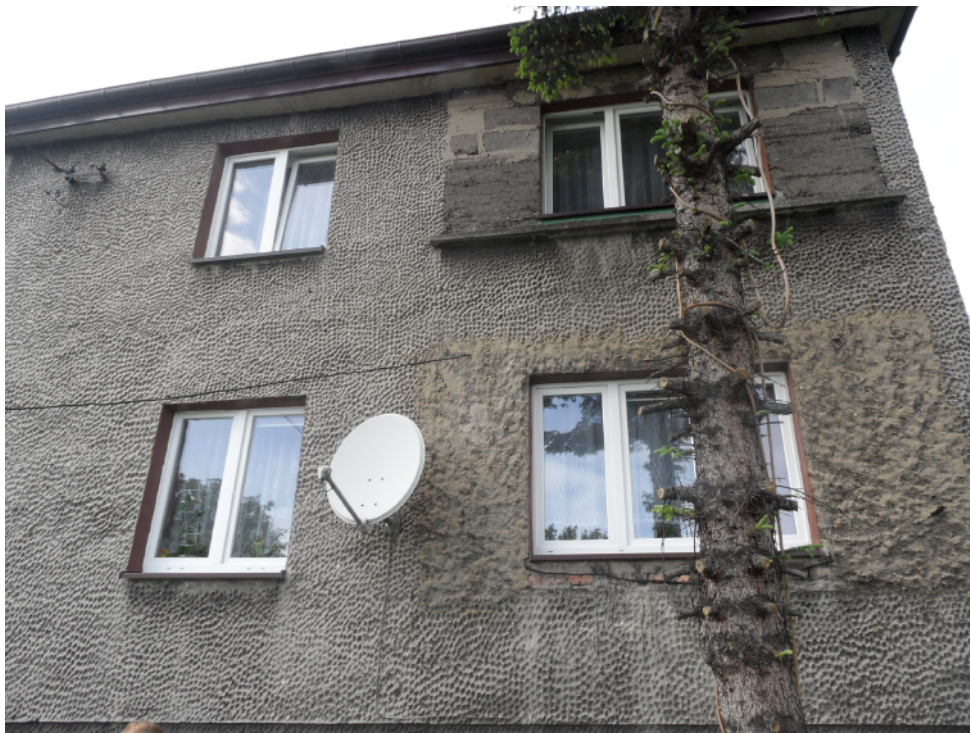
**Figure 6.**  
General view of the southern wall of the building

A general view of an external wall of the building is shown in Fig. 6. As a result of an inspection of the building, the following damage was found:

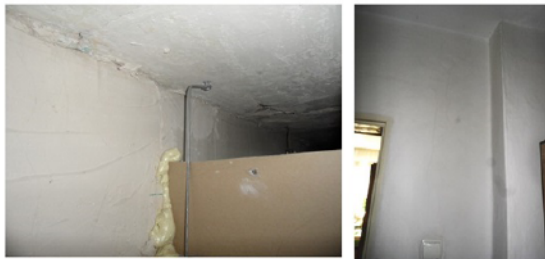
**Figure 7.**  
Cracking of the walls and ceilings inside the building

- cracking of the external walls of the building,
- cracking of the walls and ceilings inside the building (Fig. 7),
- the slope of the floor is strongly felt, and
- cracking of the splash apron around the building and the entrance stairs (Fig. 8).

The causes of building damage were both continuous deformation and ground shocks. Continuous deformation of the ground caused damage in the form of cracking of the concrete splash apron around the building and cracks in the entrance stairs to the building, which were caused by the occurrence of horizontal strain and differential settlement. These cracks were up to 5 mm. The slope of the terrain determined in the ground deformation forecasts was set at over 4‰, but it was felt in the building. The inclination of

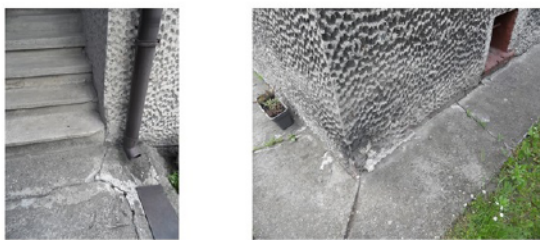
**Figure 8.**  
Cracking of the entrance stairs and the splash apron around the building

Apron failures are partly due to material or workmanship defects, but they are intensified by horizontal strain and ground settlement.
