VISUAL PERCEPTION EVALUATION OF CORTEN STEEL: ŞİMAL SHOPPING MALL

Semiha İSMAİLOĞLU ^{a*}, Ayça AKKAN ÇAVDAR ^b

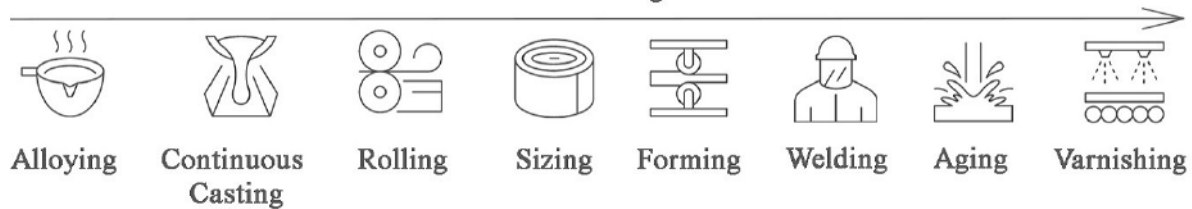
Figure 1.
The process for producing Corten steel [Created by authors]

physical and mechanical properties thanks to the alloying elements in certain proportions that are added to them while they are still in liquid form. After the alloying process, the production phase is summarized as follows (Fig. 1). The stages include continuous casting, rolling, sizing, shaping and welding. The subsequent aging process is applied to accelerate the formation of the protective layer on the material. This application involves dipping the material into a H_2SO_4 (sulfuric acid) solution. After the steel material has dried, the surface is fixed with polyurethane varnish, which prevents surface wear. They can be produced up to 20 cm thick [3].

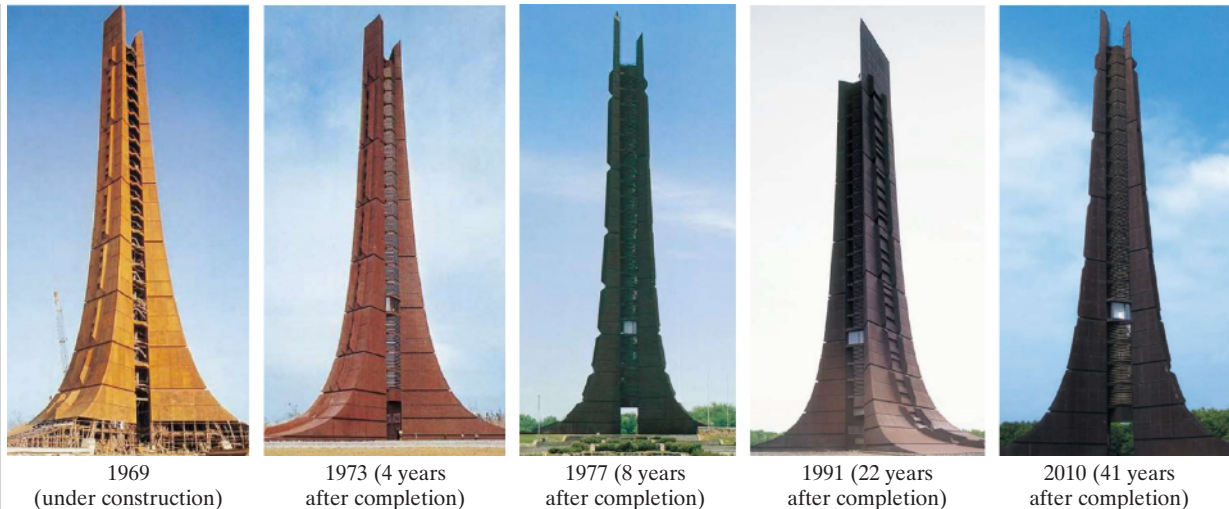
Figure 2.
Transforming the Hokkaido Centennial Memorial Tower over the years [8]

used in regions where there is water [5]. The color-changing surface and chemical properties of Corten steel are also one of the reasons why it is preferred. This feature is used especially in sculpture arts [6]. The reason for the color change is that it forms a corrosion-resistant oxide patina over time in outdoor conditions, and this situation continues [7]. Fig. 2 shows the color change of the Corten steel material used on the façade of the Hokkaido Centennial Memorial Tower over a 41-year period.

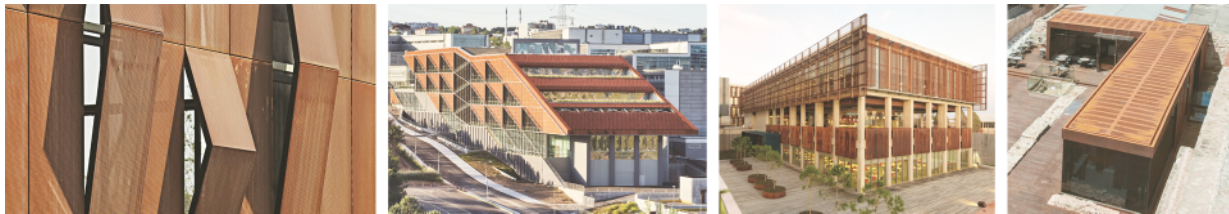
Figure 4. Raif Dinçdök Cultural Center, Özyeğin University Faculty of Architecture and Design Building, Piri Reis University and Tekfur Palace Museum [created by authors with photos from [17]]

It is seen that Corten steel, a material more commonly used in the field of architecture abroad, has also been preferred in Turkey for facade design, especially in recent years. Sample projects where Corten steel material is used include the Raif Dinçdök Cultural Center, Özyeğin University Faculty of Architecture and Design Building, Piri Reis University, Tekfur Palace Museum, and Rize Şimal Shopping Mall [17] (Fig. 4).

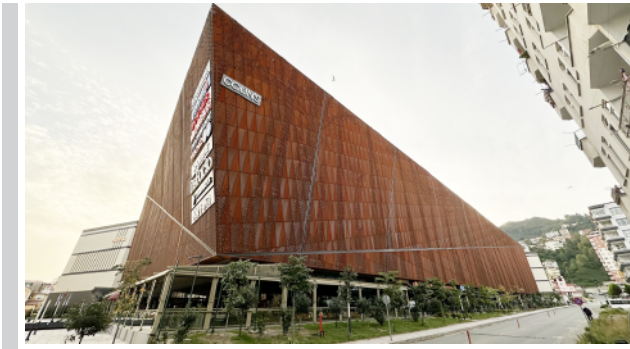
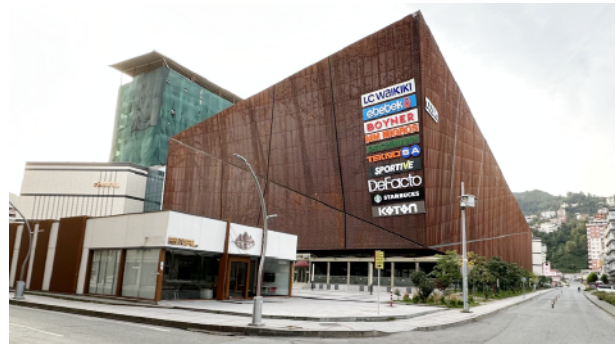
Figure 6.
Rize Şimal shopping mall exterior [Source: Authors]

interesting facade design in its region. The holes of the perforated cladding also reveal a picture of nature when viewed on a large scale (Fig. 6).

The design team stated that the main factor in choosing Corten steel material was aesthetic concerns. Although Corten steel is an expensive material, it was chosen because it was wanted to be one of the symbolic structures in Rize. In addition, the fact that the material does not require maintenance and is a living (continuous) material has influenced its selection. For this reason, the minimal pollution impact on the surroundings was deemed acceptable. The material's usage in England, which has a similar climate, influenced its selection. The material was delivered to the construction site sized according to the unit dimensions and directly assembled.
