TESTING OF RC BEAMS WITH CFRP STRIPES ON BEAM SIDE SURFACES

Witold WOŁOWICKI ^a, Lech APANAS ^b

The paper presents description of experimental testing of RC beams strengthened with CFRP stripes glued to beam sides. Test results are presented and discussed. The aims of testing were: identification of mechanism of failure of such beams, assessment of interaction of CFRP stripes and concrete with possibility of stripes lamination included as well as assessment of effectiveness of strengthening. Testing concerned nine concrete beams (including seven strengthened) and four RC beams (all strengthened). Tested RC beams failed due to loss of bearing capacity of compression zone in concrete. Stripes glued to beam sides were not torn away prior to beams failure, effectiveness of strengthening was proved to be sufficient. Stripes had beneficial influence on layout and width of cracks – large number of crack resulted in their small widths. Stripes enhanced range of linear loading-deflection relationship. This alteration was caused by yielding of reinforcement and beyond-elastic strain of concrete or reinforcement and plastic stiffening.

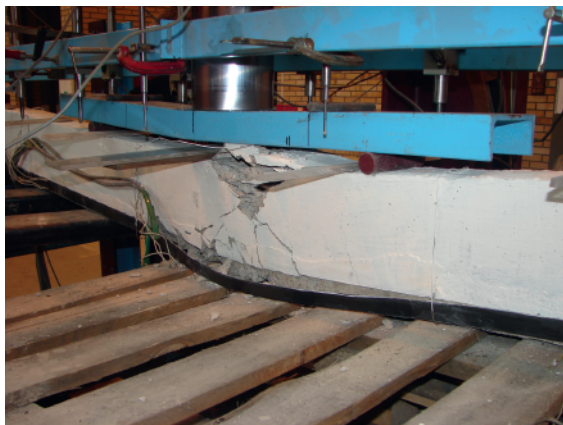
Figure 4.
Failure of beam II-1

Both beams tested in this series failed due to loss of bearing capacity of compression zone (Fig. 4, 5). Stripes glued to beam side surfaces did not tear away, even in case of beam II-2, where stripes were not extended beyond supports axes. The actual degree of reinforcement for the beam II-1 was 2.30 (computed – 1.32), and for the beam II-2 – 4.22 (computed – 2.93).

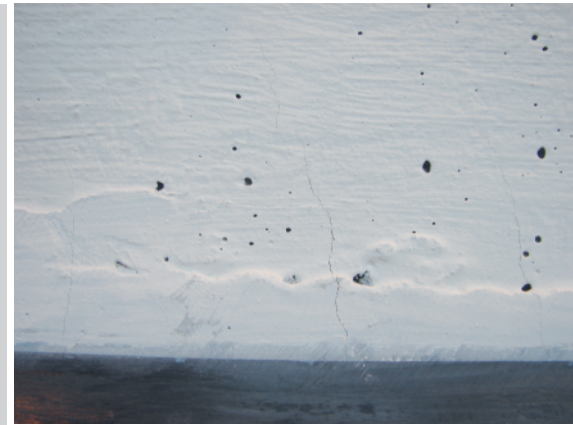
Figure 9.
Cracked beam II-2

In the cycle leading to failure, crack development was clearly influenced by strengthening stripes. First cracks above stripes were observed at loading exceeding significantly non-strengthened beam bearing capacity. The cracks were hard to notice with small spacing and concentrated at loaded cross-sections. Cracked regions widened towards midspan and supports with loading increase. At 65-70% of ultimate loading the cracked region covered half of beam length, and crack width did not exceed 0.05 mm. Fig. 8 shows the beam II-1 midspan, where at 84% of ultimate loading (47 kN), the two cracks spaced by 10 cm, increased their width up to 0.1 mm. Near ultimate loading inclined cracks appeared, and cracks in the midspan kept widening significantly up to failure. Cracks in the beam II-2 with lower degree of reinforcement appeared and developed at a bit lower stress levels. Fig. 9 shows a fragment of beam with characteristic inclined cracks at 45 kN load level, i.e. 88% of ultimate loading.

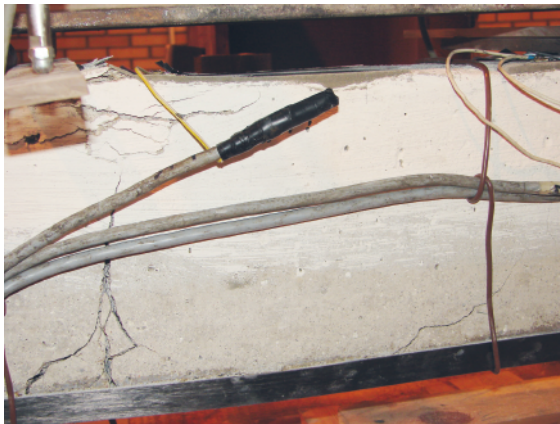
Figure 12.
Failure of beam III-2

Both beams tested in this series failed similarly to beams of series II, due to prove by recordings strains in concrete and loss of bearing capacity of compression zone. Fig. 12 shows failure region of beam III-2. Stripes glued to beam side surfaces did not tear away despite of being ended 15 cm away from support axes (on each end) towards midspan. Actual degree of reinforcement in case of beam III-1 was 3.73 (computed – 3.17), and in case of beam III-2 – 1.78 (computed – 1.28).
