DEFECTS AND DAMAGE TO SUPPORT STRUCTURES OF BIG POWER TRANSFORMERS AS A REASON OF SOIL CONTAMINATION

Abstract

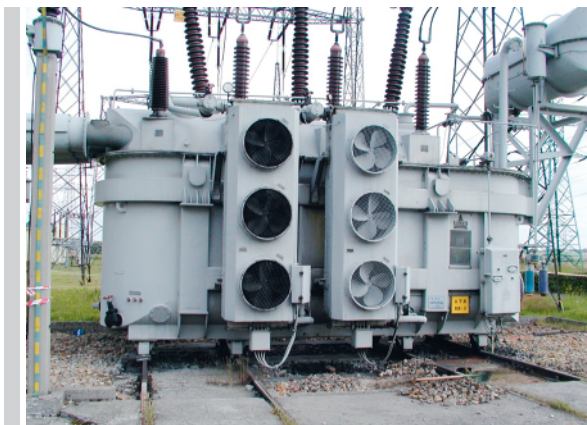
Third of the elements i.e. an oil tank, from the load bearing capacity point of view, is a secondary structure as it carries relatively little soil and possible ground water pressure as well as load from steel grate covered with mesh or platform crates and extinguishing stone layer (fig. 2). In case of typical tank the walls were constructed as reinforced concrete monolithic walls, and the bottom as a concrete or reinforced concrete slab. In most of transformers used in Poland, of top voltage equal 110 kV or more, a typical solution with an oil tank described above was employed.

Figure 2.
220/110 kV transformer on a work station

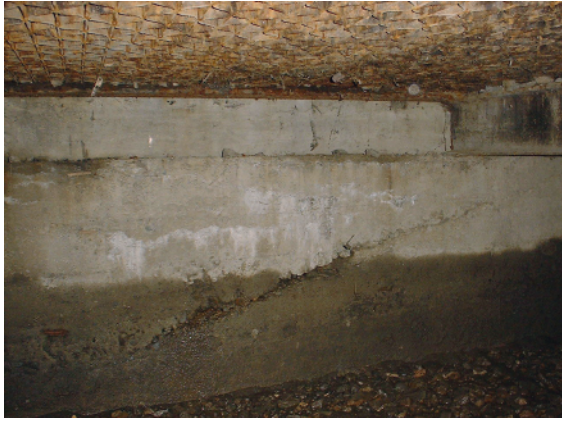
The most often encountered design and constructional flaw is lack of any insulation from a tank inside side – it refers to both walls (fig. 3, 4, 5) as well as a bottom. Such a situation causes penetration of oil into the smallest cracks in concrete as well as supersaturation of the surface layer of uncracked concrete.

In practice it makes execution of any repairs or a construction tightening much more difficult as it almost entirely eliminates remedial mediums adherence to original concrete. Similarly, in most cases there was no wall insulation provided from the ground side, which in case of high level of underground waters causes leaking of underground water into a tank inside (fig. 3) and fast destruction of almost permanently damp concrete.

Figure 3.
Lack of a wall insulation, visible defective contact between concrete layers and dampness

In case when technical condition of an oil tank makes its repair impossible, and at the same time it satisfies requirements of minimal, required capacity, a typical remedial and repair recommendations include: thorough cleaning of the whole structure, filling the cracks, reprofiling of defects in the selected PCC system, sealing of all structural contacts, and then – application of chemically resistant putty on the whole surface of all elements from the tank inside. It is also recommended to provide typical water insulation at the contact of structural elements and ground. Also possibility of safe removal of sludge accumulated inside an oil tank needs to be ensured every time. In many cases mixed solution is justified, with repair of walls and construction of a new bottom. Very often removal and reconstruction of upper thinner section of wall is recommended.

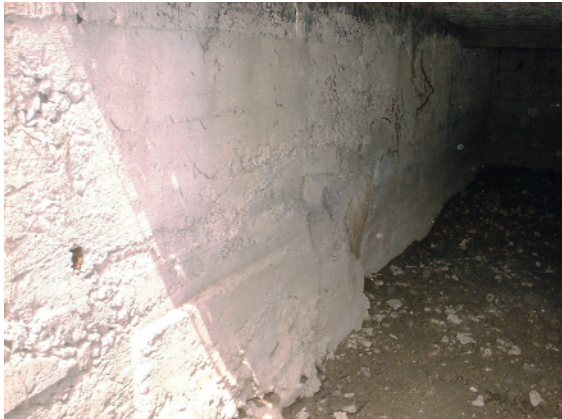
Generally the walls and bottom are made of very poor concrete – in best of the tested cases the concrete class was C12/15, very often, however, concrete corresponded to class C8/10. Regardless of bad concrete strength parameters, particularly shoddy was construction of a tank walls – numerous roughnesses, honeycombs in concrete were noted (mainly at joints of concreting stages) as well as parts of left

Figure 4.
Lack of insulation, visible numerous irregularities, honey-combings in concrete and fragment of left shuttering

shutterings. The examples of such flaws have been shown in figures 4, 5.

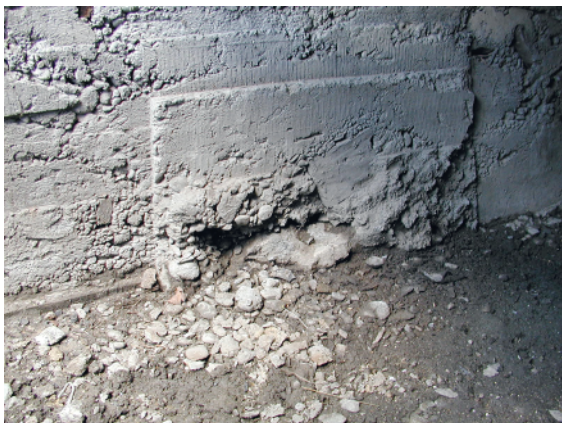
Figure 5.
Lack of insulation, visible defects of concreting

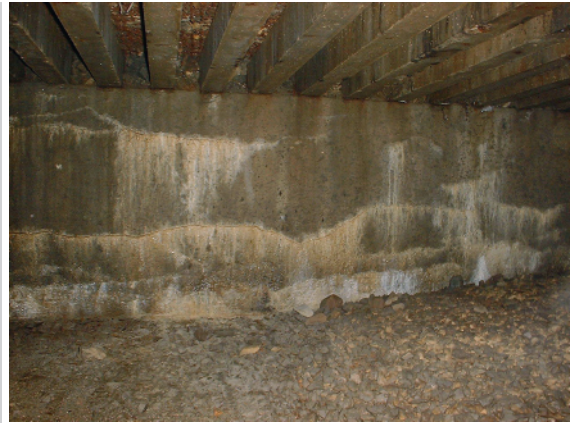
In some of the structures different intensity of cracks in the walls (fig. 6, 7) and in the oil tank bottom was observed, sometimes with traces of underground water intensively leaking into a tank. It is obvious that in case of transformer failure and filling a tank with oil it would end up with reversed direction of flow and oil would immediately get into the ground around the structure.

Figure 6.
Heavy horizontal cracking of an oil tank wall, traces of ground water leakage

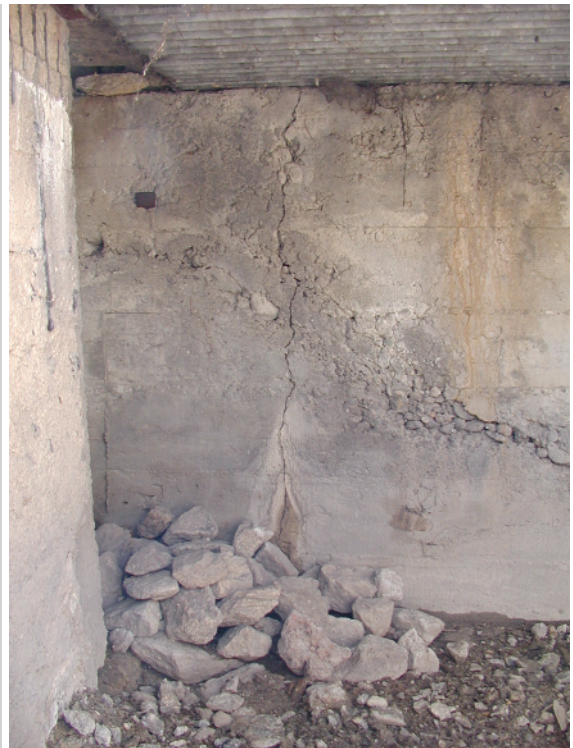
Figure 7.
Heavy vertical cracking of an oil tank wall, concrete sorting out, traces of leakages

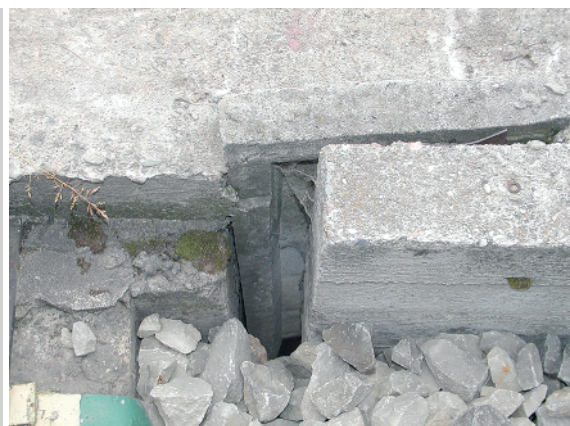
Lack of an oil tank tightness in many cases resulted also from improper construction and protection of joints between basic constructional elements constituting part of foundation as a whole. The worst point here is almost always contact between an oil tank and construction of an approach continuous footing. This point is presumably faulty because in a typical construction a continuous footing disturbs continuity of a wall. It needs to be emphasized that in any of tested foundations, a contact of these two elements was properly sealed, and in individual cases (fig. 8) vertical gap on the whole height of the wall reached the width of 10 cm. Similarly, in all cases proper seals were missing at contact of continuous footing and proper foundation as well as at contact of a tank bottom with a foundation vertical planes.

Figure 8.
Gap at contact of an approach continuous footing and an oil tank wall

At the same time repair or replacement of a tank is usually accompanied by required repair and protection of a foundation itself and approach continuous footing - it is particularly essential due to the requirement of maintaining continuity of surface insulations.

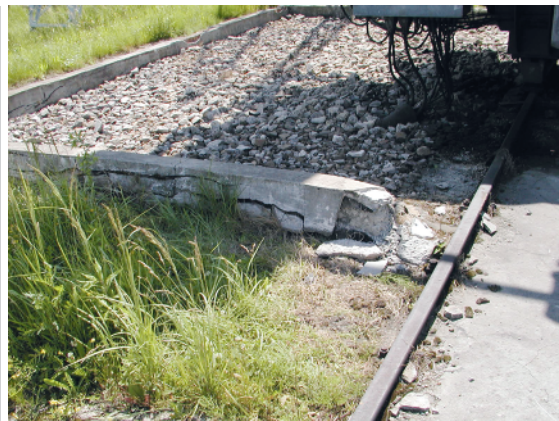
In case of a typical structure theoretical capacity of a tank includes hollows in a foundation as well as capacity limited by a top section of a circumferential wall, above the ground surface. Practically, in all cases evaluated by the authors upper, substantially thinner section of a wall was constructed without reinforcement and thus considerably weaker. The effect of it is great number of cracks, and in extreme cases almost entire destruction of this element (fig. 9) which results in substantial reduction of an oil tank capacity.

Moreover, due to the requirement of ensuring transformer movement, upper section of the wall on the railway subgrade width was not constructed but completed later by means of brick wall. In practice such missing part of a wall was never completed (fig. 9) or

Figure 9.
Substantial damage to upper section of an oil tank wall, lack of the drivable section filling

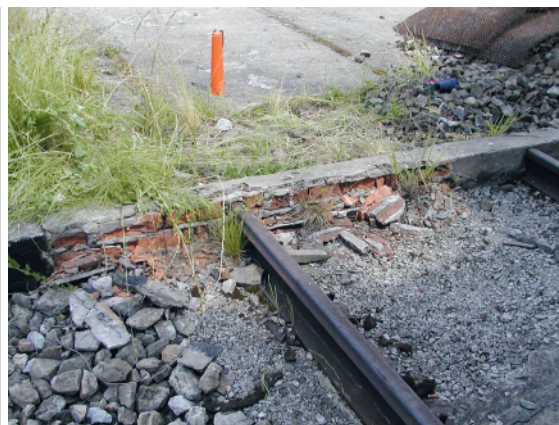
it is in very bad condition (fig. 10)

Figure 10.
Damaged brick filling of transit section of the wall
