ABANDONED TRAIN STATIONS. KATOWICE-ZWARDOŃ-ŽILINA-RAJEC

Dominika LUDVIKOVÁ *

The subject of the paper is train station. The research deal with those train stations that either no longer serve their purpose or are now abandoned. By abandoned train stations, the author of the paper means rail buildings that do not provide passengers with the necessities of cash desk and a waiting room or toilet. Stations that have abandoned their original purpose. Such stations were analysed on the only railway line connecting Poland and Slovakia operating on a daily basis. Mentioned line is connecting cities Katowice – Zwardoń – Žilina – Rajec. Much of this railway architecture is abandoned and unused. The work described in the paper aims to create a database of abandoned train stations based on authors own research and points to a large number of abandoned train stations that have potential for their future development. The data was collected by means of various methods described in the paper and was valid as of 31.12.2021. The situation today may differ.

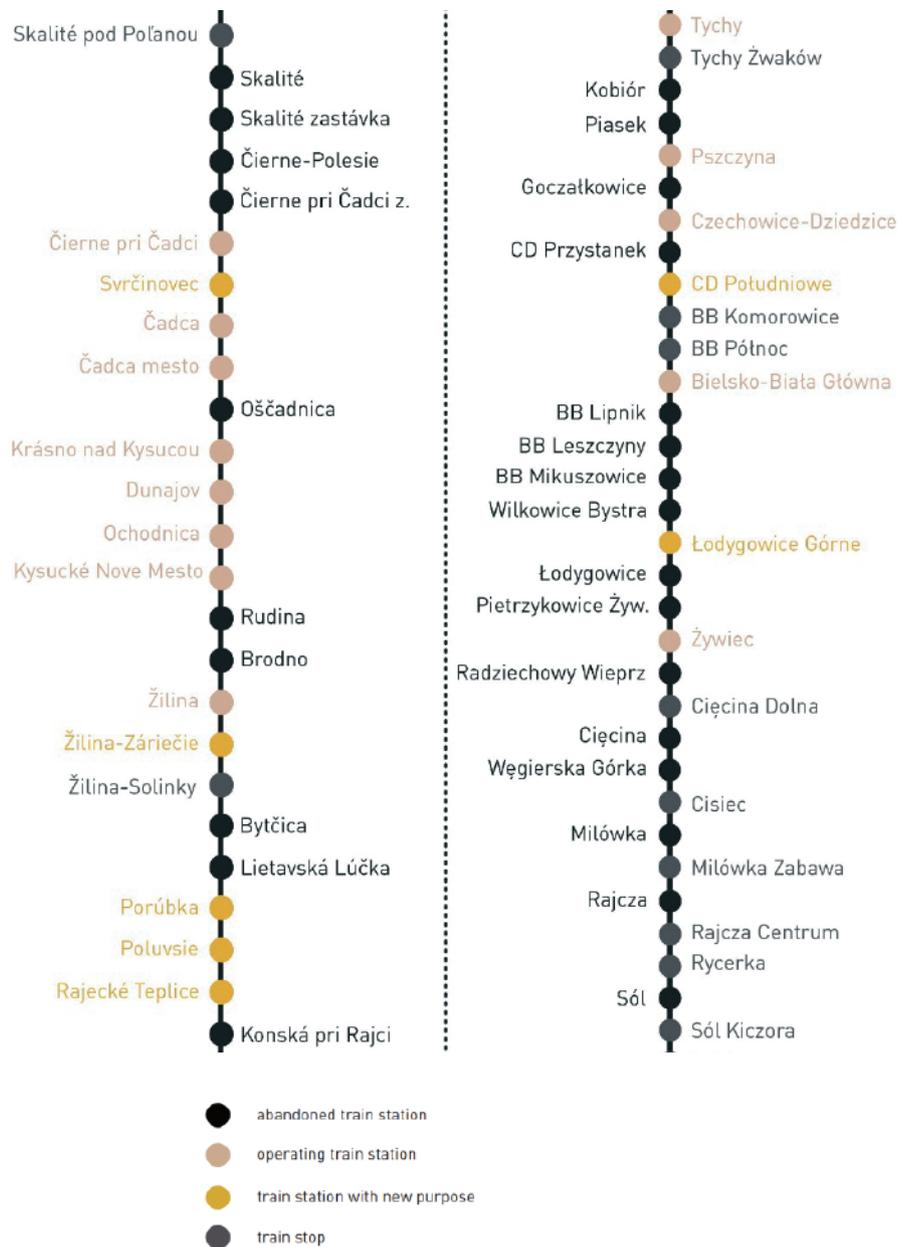
Figure 1. Division of stations by type of receiving building and current function, elaborated by Dominika Ľudviková [1]

The created database describes a total of 30 abandoned train stations depicted in black colour in figure number 1. All the train stations on the Polish and Slovak sides were examined personally by the author of the thesis. From the data collected in situ, data obtained in cooperation with railway companies and information from books and the Internet, tables with basic information about the station, its location and the receiving station building itself were created. The first table provides information on the launching of the station in its original name, and the position on a particular line with the established track gauge. The number of stops a train makes at a given station and the goods carried through it was also ascertained. The second table collects data regarding the location in which the train station is situated. The locality is described by its population, the size of the municipal-

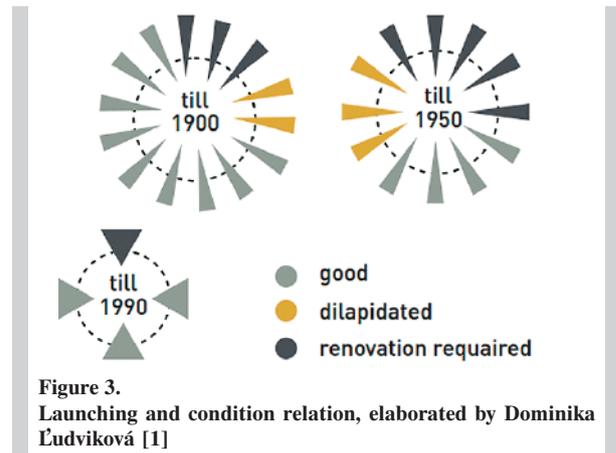
Figure 3. Launching and condition relation, elaborated by Dominika Ludviková [1]

launching. Half of the stations were built in the 19th century [13], with many of them built and opened in the same year in the very same architectural style. In some cases, this involved the unification of station buildings, which was common in architecture for this period [14]. In the second half of the 20th century, four new stations were built on the line under study, but these are now no longer serving their original purpose and are closed to the travelling public despite their late construction. Another attribute examined was the technical condition of the reception buildings. This can be considered good in 54% of cases. Five stations belong to the group of dilapidated station buildings. The last researched category is the technical condition that requires renovation. Based on observations, 9 train stations have been included in this group. In an attempt to correlate the condition of a building with its year of launching, interesting results emerged. Nine of the fourteen station buildings built before 1900 (65%) were in good condition at the end of 2021. In most cases, train stations of this dating have undergone a recent refurbishment, which unfortunately has not prevented their closure.

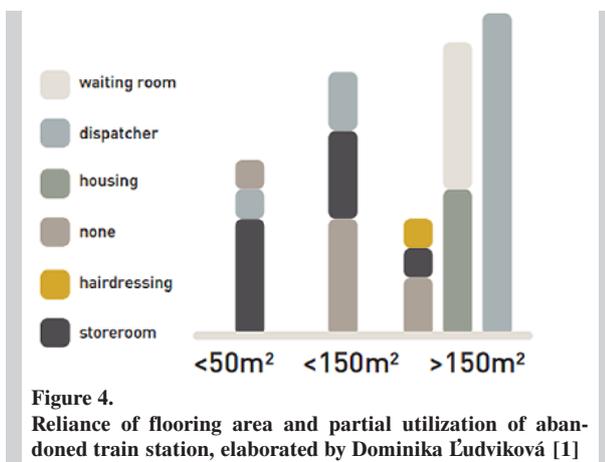
The third category of analyses is dedicated to the current partial utilization of train stations, their floor area, and the dependence of these two attributes. According to the flooring area, the receiving buildings of the train stations were divided into three groups, namely buildings up to 50 m², up to 150 m² and over 150 m². Fifteen out of thirty stations have a receiving building with a flooring area greater than 150 m². The group up to 50 m² has the smallest representation, which includes 6 train stations. The survey of current station utilisation identified 5 functions, with nine of the stations surveyed not perform-

ing any function at the time of the survey. The most common partial use of train stations is a room for train dispatchers. This function is questionable for the future of the railways, as many of the railway lines are already electrified today and thus the role of the dispatcher is unnecessary [15]. The next function whose existence within the train stations is questionable is the storage of railway tools. Such a use can be found only on the Slovak side of the railway, and it is evident from the in-situ observation that nothing is being stored in the building. The author of the thesis, therefore, believes that this function is in most cases fabricated by the railway company. In five cases a passenger waiting room was found. However, its operation is very limited, as most of them are only accessible at certain time intervals, possibly 15 minutes before the arrival of the train. One or two dwelling units, mostly in original condition, were found in five stations. The last feature is a hairdresser's shop, which was located in one of the Polish stations [16]. However, it occupies only a small percentage of the flooring area, is in a dilapidated building with unmaintained surroundings, and thus its function was assessed as not beneficial to the original train station. A chart dealing with the comparison of uses as a function of flooring area showed that the larger the receiving building is, the more likely a function will occur. Likewise, with a larger floor area, functions are more varied. For stations with a floor area of less than 150 m², functions such as waiting room or housing will not occur. This may also be due to the location of such small stations as they are mostly found in smaller villages.

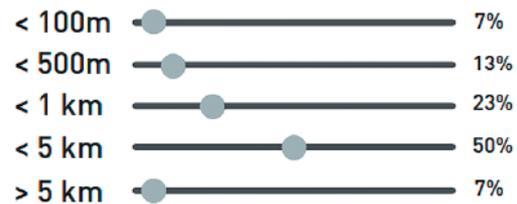
Figure 5.
Distance from the train station to municipality centre, elaborated by Dominika Ľudviková [1]

ferring to another public transport mode were examined. Finally, the overall accessibility of the stations was evaluated. The statistics showed that 50% of the surveyed stations were located on the periphery of the villages. The smallest percentage, 20%, has stations located in the city centres. Nineteen of all the stations selected provide the possibility of transferring to another public transport mode, while the distance to the station does not exceed a walking distance of 5 minutes, approximately 250 metres from the train station. More than half of the stations do not offer the possibility of legal car parking in close proximity to the station. This is also true for bicycle parking, with 57% of the stations surveyed having a bicycle path or marked bicycle route in their vicinity. The same percentage of stations have a distance from the station to the village centre greater than 1 kilometre (approximately 20 minutes). Because of this long distance, in most cases, passengers are not willing to commute and therefore choose to drive. Thirteen train stations are within a walking distance of 1 kilometre from the municipality centre. Combining all the above factors and statistics, we can evaluate that up to 97% of the stations on the described line are accessible by one of the mentioned methods. There is only one station in the database, namely Skalité Serafínov on the Slovak side near the border, which is very difficult to reach. There is no cycle path in its vicinity, no parking lots and it is not within walking distance of any other means of transport. Its distance from the centre is 7.2 kilometres.

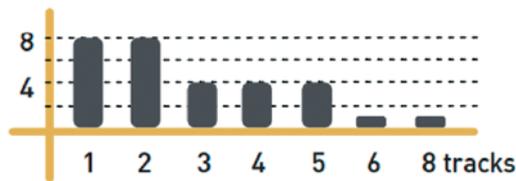
Figure 6.
Number of tracks in abandoned train stations premises, elaborated by Dominika Ľudviková [1]

within their premises. The existence of other railway buildings in the station areas was investigated. Within the premises of 13 abandoned train stations, there is some other railway building. These are, for instance, draws, heating plants, waterworks, depots, guard houses and housing in general among others [11]. Concerning the reception building itself, in 17 cases the building has one floor. More than half of the researched stations have an attic that could be used for new purposes. Two two-storey and one single-storey building were proved to have basements. However, the presence of basements could not be ascertained for many of the station buildings. Therefore, the statistics on the number of cellars cannot be considered reliable. The last attribute examined in the group was the number of tracks in the train station area. Sixteen stations from the database have one or two tracks. For such stations, it is not possible to consider the use of tracks for other purposes as they are essential for the operation of the train service. The remaining 14 stations possess more than 2 tracks. Thus, some of them which are not in use could be adopted for new functions.

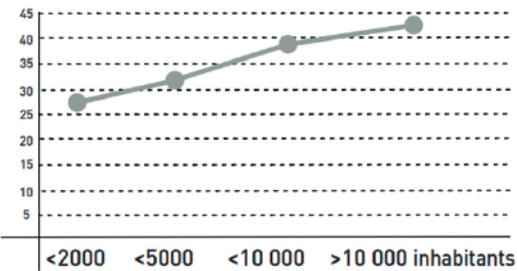
Figure 7.
Average train stopovers per population, elaborated by Dominika Ľudviková [1]

that low station serviceability is also associated with locations which are more difficult to reach. Less accessible terrain with deteriorated infrastructure may be the reason for the low frequency of cargo trains. The last diagram of the group aimed to find the dependence between the population of a municipality and the number of train stops. It was shown that these values are relative to each other. As the population increases, the station serves more trains and therefore more passengers per day.
