The Silesian University of Technology

IMPACT OF ENVELOPE STRUCTURE ON THE SOLUTIONS OF THERMAL INSULATION FROM THE INSIDE

Bożena ORLIK-KOŻDOŃ a*, Agnieszka SZYMANOWSKA-GWIŻDŻ b

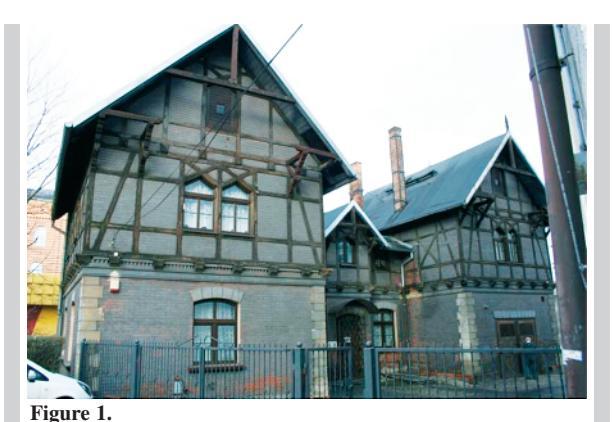
Prussian wall in the building of State Music School in Gliwice [11]

The subject of the authors' research involves timberframed wall structures with a ceramic brick filling, referred to as Prussian wall. An example of such a half-timbered structure is the building of the existing State Music School, dated the beginning of the 20th century, located in Gliwice (Fig. 1). The frame structure was applied in the walls of the first floor, and the ground floor was made entirely of a brick wall. The rooms on the first floor contain a library and music rooms for students to practice.

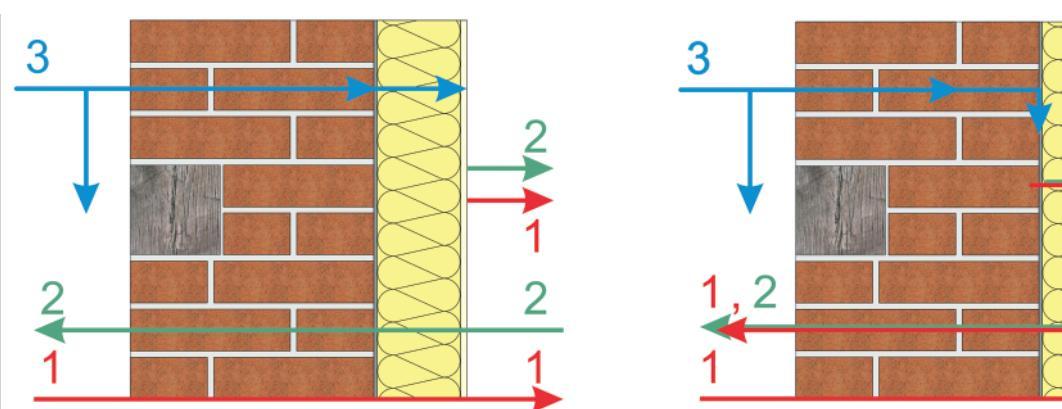
Figure 2.

a) Capillary-active method

b) Method with vapour barrier

Selected insulation methods from the inside for the Prussian wall [16] (1 – summer vapor diffusion flux, 2 – winter vapor diffusion flux, 3 – flux of slanting rain)

When using interior wall insulation, we can choose three main solution concepts (Fig. 2):

• Insulation from the inside, minimizing the development of condensation (Fig. 2a)

• Insulation from the inside, permitting the development of condensation, with provided justification or proof that the condensate formed during the unfavorable period evaporates during the calculation year (Fig. 2b)

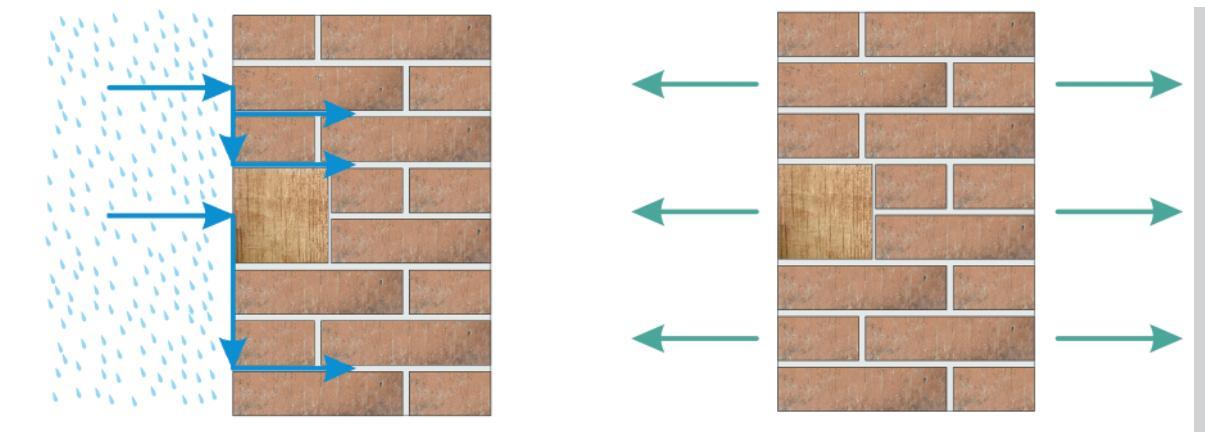
Figure 3.

Moistening with lashing rain and drying-out of the non-insulated Prussian wall

The envelopes in the Prussian wall system are characteristic of the presence of gaps between the frame and the adjacent elements, allowing the penetration of rainwater into the wall (Fig. 3). Studies have shown [17] that it can penetrate the wall to the depth of 20 cm. Such a phenomenon was described by Kozakiewicz [18], who also pointed to the aging processes and slow losses in the cross-section of wooden elements. CIVIL ENGINEERIN

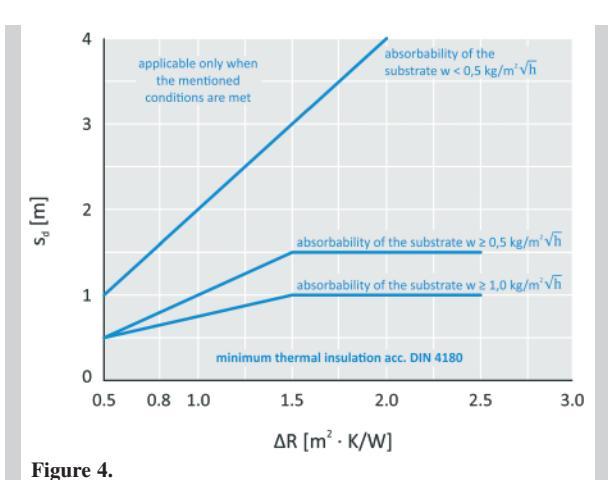
Minimum requirements involving thermal insulation layer, depending on the thermal resistance of insulation for substrates characterized by different capillary activity [20]

In 2009, the document WTA - Merkblatt 6-4 2009-05 [20] has been published in which selected issues concerning the design of thermal insulation from the inside were presented. Such solutions lead to coolingout of the structural part of the wall, and hence they reduce the drying-out process of the existing structure. The presented procedure allows, in a simplified way, to estimate the correctness of the choice of a material solution, in terms of water absorption of the existing envelope and its outer layer. The first element of the procedure is to determine the impact of rain on the outer coating of the wall, i.e. to determine its water absorption expressed in W_w [kg / m² h^{0.5}]. If there is sufficient protection against rain in accordance with DIN 4108 [15], (part 3), it is usually sufficient. If the condition is not met, the following diagram is applied (Fig. 4) [20].

the existing rain protection of the façade is efficient, the existing external wall has the thermal resistance of at least R≥0.39 [(m² K)/W]; the normal climate prevails in the room, according to the definition given in WTA [20]; the average annual temperature of outside air exceeds 7°C, and the improvement of resistance ΔR should not exceed 2.5 or 2.0 [(m² K)/W]. If one of these requirements is not met, detailed analyzes and calculations are required.

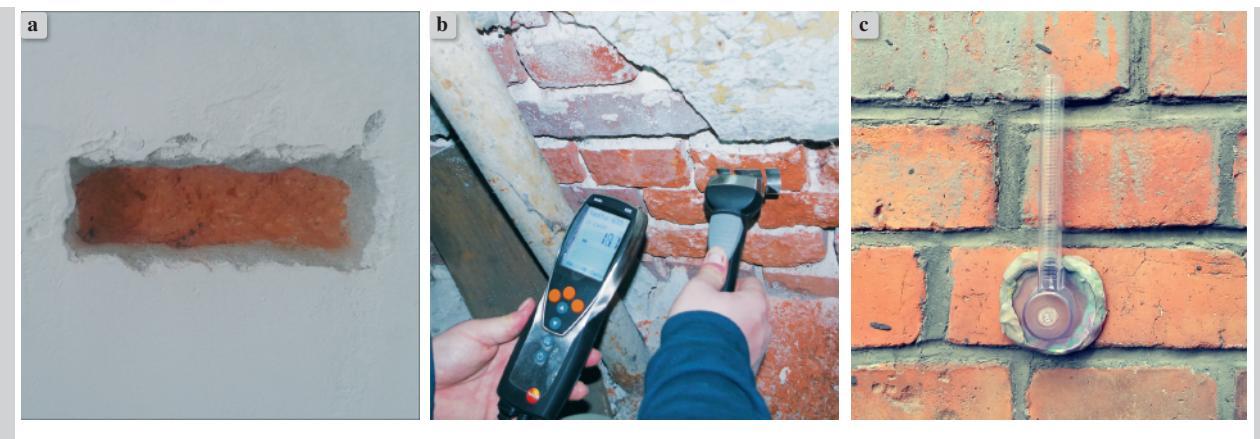
Figure 5.

a) Making opencasts and collecting material for the wall from the room side; b) Measurement of surface humidity; c) Measurement of water absorbency of the wall

- identification of material structure of the envelope, including the made opencasts; measurement of the thickness of the existing layers (Fig. 5a),
- measurement of surface moisture using non-invasive methods; close to ceramic walls of the thickness above 51 cm, measurement of mass humidity by collecting samples from the outcast (Fig. 5b),

The measurements were made in three opencasts, at three heights, after the removal of plaster off the brickwork. The measured surface humidity was the highest close to the flooring, and it decreased with the height. On the façade, damage to the bricks was identified, which is characteristic of progressing capillary action. The strongest damage was observed by the ground and up to the height of about 150 cm. The measurements confirmed the diminishing level of moisture (17% by the ground, 2.5% at the height of 175 cm). Also brick brittleness and discolorations were found. The lowest bricks were chipped. At moistened places, biological growth was visible. Similar damage occurred in the zone near the ground on the remaining façades.

• determination of capillary absorbency of the wall (Fig. 5c)

The determination of capillary absorbency of the wall was carried out using the Karsten tube [21, 22].

The measurement defined the extent of water penetration in the plane of brickwork. The measurement results for the brickwork are 5-7.3 (kg/m²h^{0.5}).

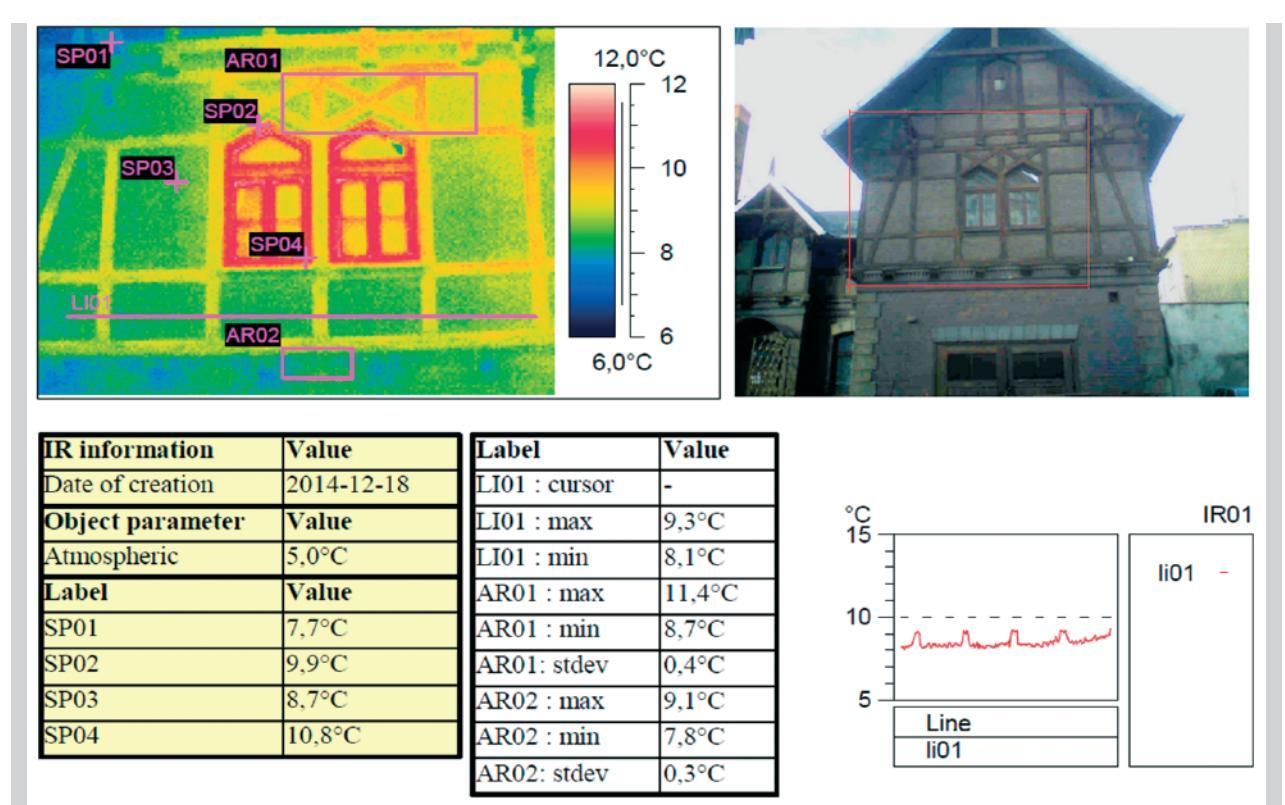
Figure 6.

Thermogram made from the outside of the building in Gliwice

The obtained temperature difference between external and internal air (about 15 K) meets the requirements of the PN-EN 13187 standard – the minimum temperature difference at the level of Δt_{min} > 10 K. Thermovision tests were conducted from 7 pm to 9 pm.

Analysis of the obtained thermograms showed no gaps or cracks at places where wooden elements got into contact with the wall for the investigated building.

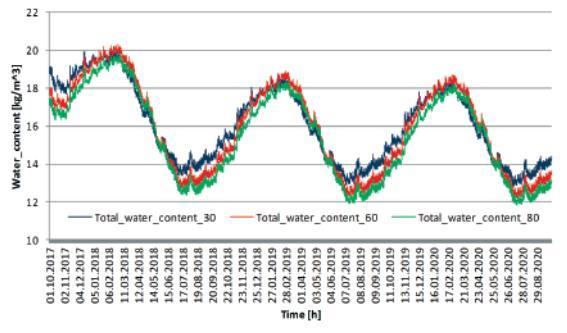
Figure 7.

Total water content in the envelope (25 cm) insulated with lightweight cellular concrete (markings: 30–30 mm insulator; 60–60 mm insulator; 80–80 mm insulator)

In the presented case (Figs. $7\div12$), the analysis of the proposed solution did not confirm the accumulation of moisture inside the envelope for a given calculation period. Both the application of porous concrete materials (Figs. 7, 8, 9) and barriers in the form of polyurethane panels (Figs. 10, 11, 12) did not raise the water content of the envelope. It should be mentioned that the envelope modeling was carried out assuming full tightness of the external wall (its facade layer). The graphs demonstrate (Figs. 8, 11) that the water content in the cross-section of wooden element exceeds 100 kg/m³ and shows a downward tendency drving out to the level of \sim 75 kg/m³. With respect to the biodegradation of wood, the moisture content in wood should not exceed 20% of the volumetric weight. Slightly higher values are permitted for a period of 6 months.

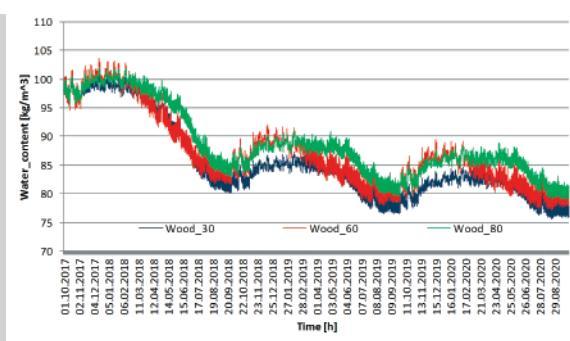
Figure 8.

Changes of water content over time in a layer of the wooden frame stud in the wall insulated with lightweight cellular concrete (markings: 30–30 mm insulator; 60–60 mm insulator; 80–80 mm insulator)

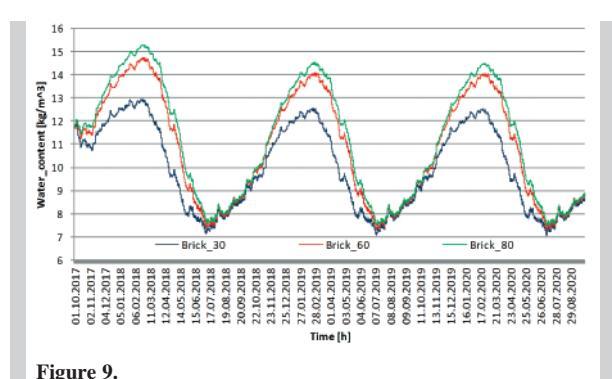
Changes of water content over time in a layer of the brickwork (25 cm) insulated with lightweight cellular concrete (markings: 30–30 mm insulator; 60–60 mm insulator; 80–80 mm insulator)

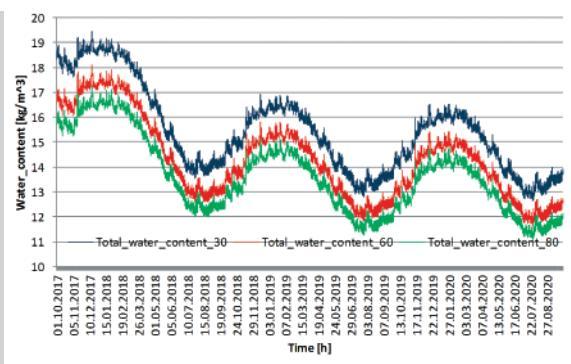
Figure 10.

Total water content in the envelope (25 cm) insulated with polyurethane panels (markings: 30–30 mm insulator; 60–60 mm insulator; 80–80 mm insulator)

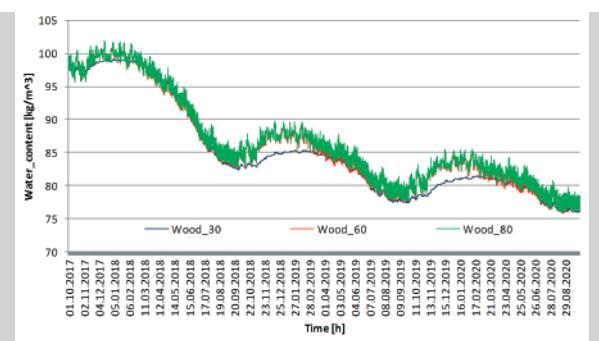
Figure 11.

Changes of water content over time in a layer of the wooden frame stud in the wall with polyurethane panels (markings: 30–30 mm insulator; 60–60 mm insulator; 80–80 mm insulator)

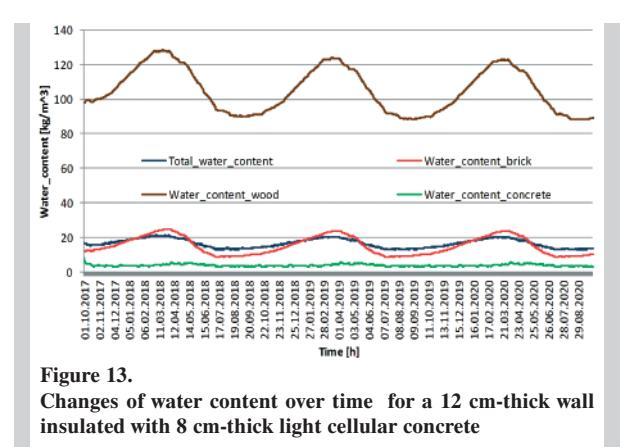
Fig. 13 presents changes of water content in the particular layers of the 12 cm-thick walls insulated with 8 cm-thick thermal insulation material (lightweight cellular concrete). Water content in wooden elements exceeds 20% (\sim 130 kg/m³ in the winter season). In the summer season, the level of water content drops to 90 kg/m³. We must add that such a situation becomes disturbing with heavy rainfall. Rainwater can penetrate to the depth of about 20 cm [13, 14, 17] and can extensively dampen the envelope, resulting in the degradation of its elements. In such a situation the insulating material itself (light cellular concrete) loses its insulation qualities since the pores are filled up with water.

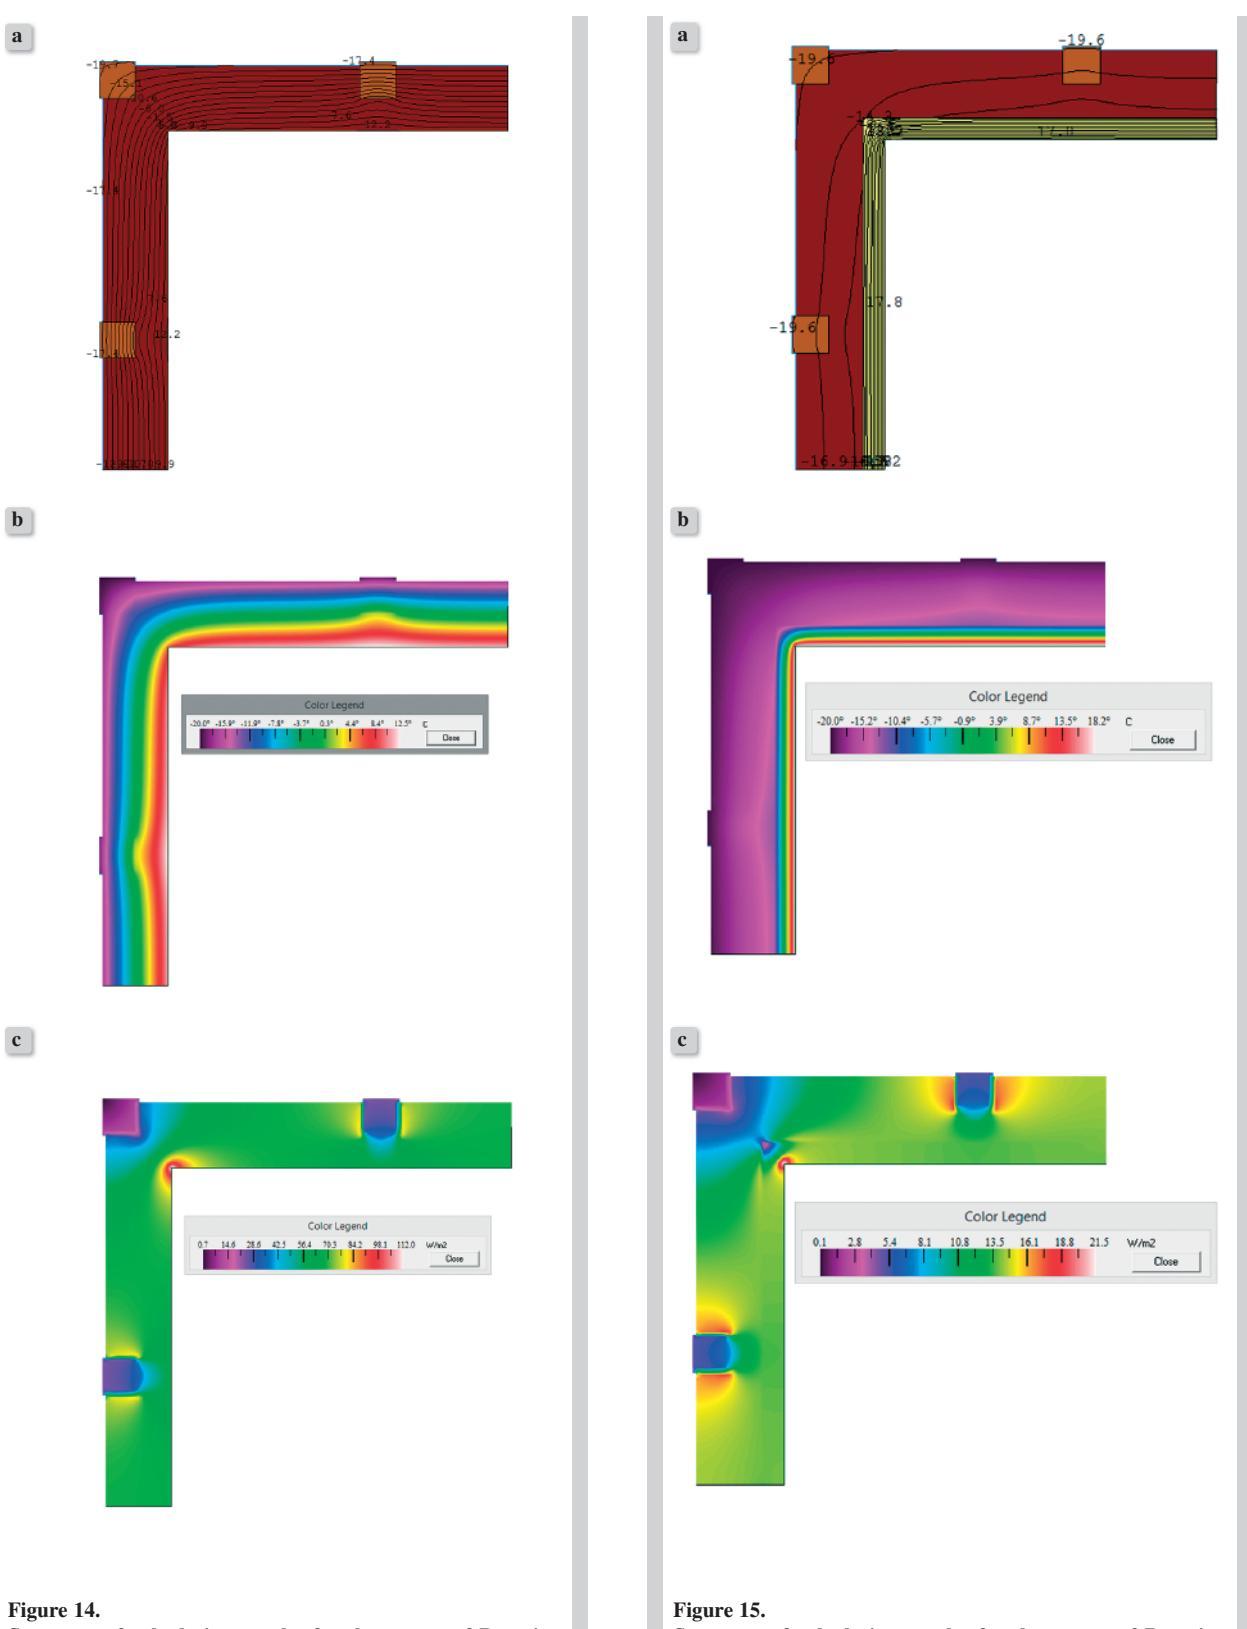
Summary of calculation results for the corner of Prussian wall without thermal insulation (a, b – distribution of isotherms, c – distribution of heat flux density)

The obtained results (Tab. 2) demonstrate that there is a risk of surface condensation and mold growth for the non-insulated wall. The value of the temperature factor f_{Rsi} is lower than the permissible value of 0.72 [1]. For the thermally insulated wall the risk is eliminated, but we can observe a high impact of external temperatures on the structural part of the wall (masonry).
