## BEHAVIOR OF DAMAGED MASONRY INFILL PANELS IN RC FRAMES SUBJECTED TO OUT OF PLANE LOADS

M. F. Paulo PEREIRA <sup>a</sup>, M. F. Neto PEREIRA <sup>b</sup>, J. E. Dias FERREIRA <sup>b</sup>, P. B. LOURENÇO <sup>c</sup>

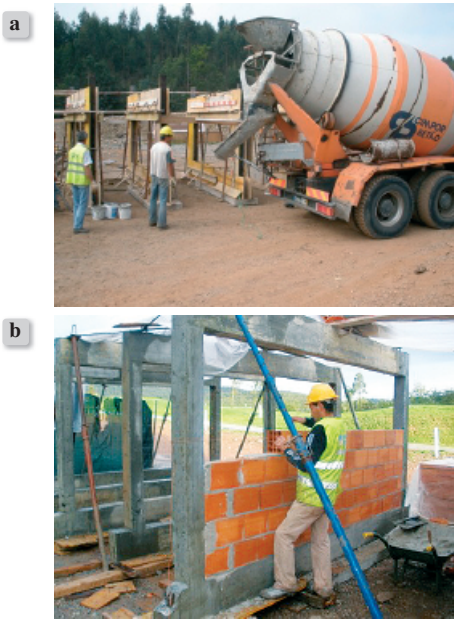
Figure 5. Construction phases of the panels: a) frame concreting; b) wall construction

The aim of the experimental campaign is to determine the behavior of masonry infill panels in RC frames, with and without reinforcement, constructed according to the traditional building process. The construction process of the walls consisted of the following steps: 1) construction of the concrete frames; 2) construction of masonry infill panel with or without reinforcement; 3) placement of plaster with or without reinforcement, as is briefly described in Figure 5. The construction process of the masonry walls is particularly important because it may result in different behavior. The placement of the masonry is done by successive horizontal rows, always from one of the pillars. At first masonry unit, mortar is applied on the bed and head faces. The unit is then pressed against bed and the column. The last unit in each horizontal row is usually cut due to dimensional compatibility. In situations where the panels geometry make the cut unreasonable (too small unit parts), the spaces are filled with mortar. The geometry of the panel led to a situation of this kind. In the last horizontal row units are cut so they can fit to the concrete frame geometry. The space between the unit and the beam is filled, possibly only partly due to execution difficulties, with mortar.

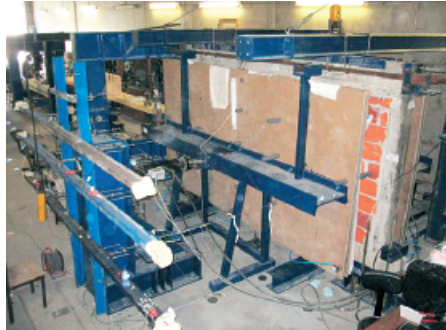
**Figure 12.**  
Out-of-plane instrumentation: a) Scheme; b) Overview

In order to perform the out-of-plane test, an instrumentation plan was created, Figure 12. The aim of the instrumentation is to know the displacements of vari-

ous points of the panel in order to gather the most relevant data to the knowledge of the behavior of masonry wall when exposed to actions outside the plane.

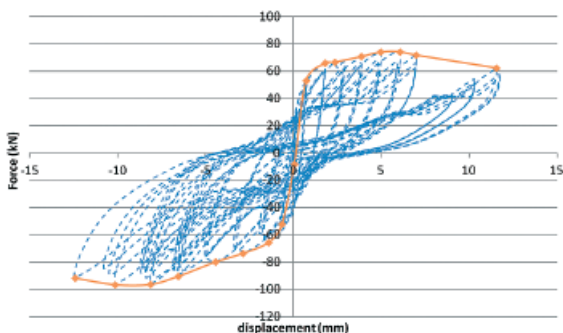
**Figure 13.**  
Results and experimental envelope of in plane test performed to WALL\_REF\_01

between the top of columns and masonry; 3) sliding of the top joint between the upper beam and masonry; 4) beginning of crushing in the top joint corners, between top beam and masonry; 5) start of crack development; 6) development of a diagonal crack in the junction of the upper beam and the column, at the load application node. Maximum resistance is reached just before the interface or corner masonry crushes. Since this moment, there is a gradual loss of strength, as shown in Figure 13.

The load direction had direct influence in the maximum strength and drift (relative displacement). The maximum resistance is 96.1 kN and the minimum its 73.9 kN, for drifts of 0.37% and 0.19% respectively. The direction which has less resistance is related to the constructive process and matches the closing of the panel.

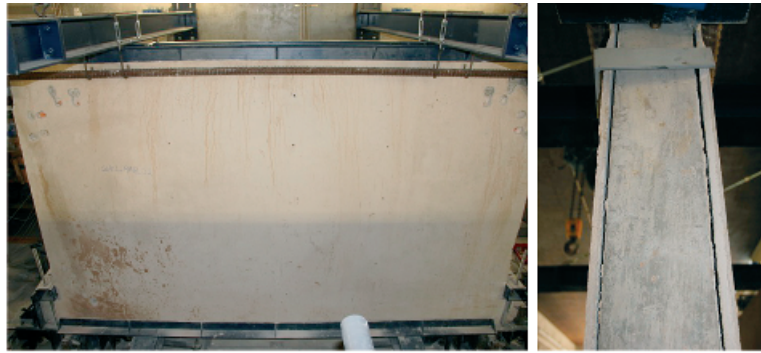
Figure 17. Plaster condition in the end of in-plane test

Figure 17 shows the plaster condition at the end of the in-plane test. It is possible to observe that the rag bolts that connect the reinforced plaster to the RC frame does not work properly, as during the in-plane test the plaster detached from the concrete structure.

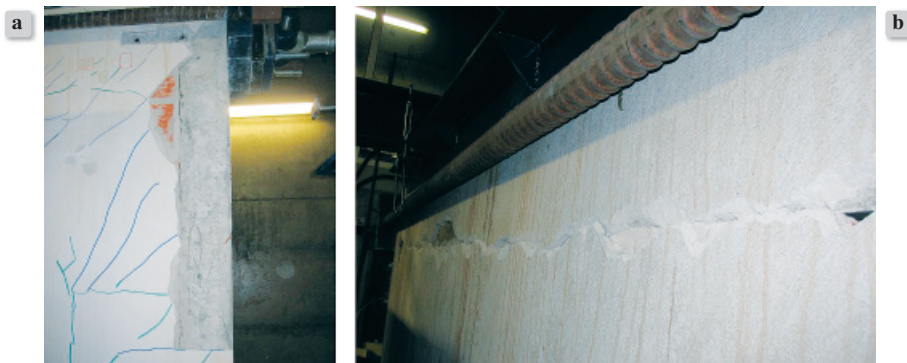
Figure 19. In-plane apparent state of damage: a) lateral interface; b) upper interface

In the in plane tests, it was possible to notice that the interfaces masonry/RC frame have lost their stiffness or got crushed specially in the upper interface, as it is shown in Figure 19. This fact is important as the out-of-plane test would not represent in the best way the seismic behavior without this previous damage, as it would neglected combined seismic effects.

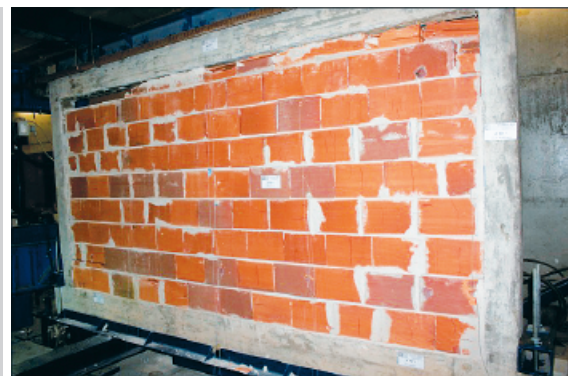
Figure 22.  
Crack pattern after out-of-plane test

Figure 22 illustrates the crack pattern after the out-of-plane test performed in WALL\_REF. As it can be observed the upper left corner is partly collapsed, the upper right corner is totally damaged and there is a crack 25 cm above the lower beam, which indicates a cantilever type structural failure.

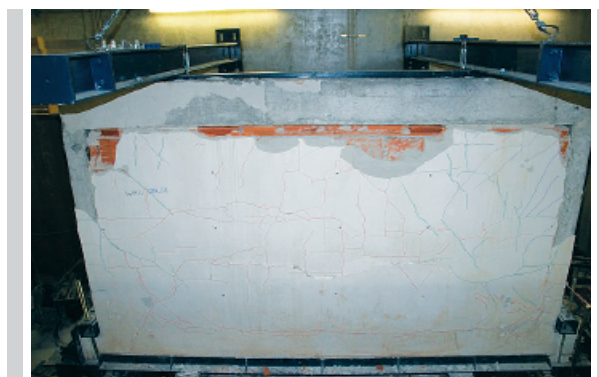
**Figure 24.**  
Crack pattern after out-of-plane test

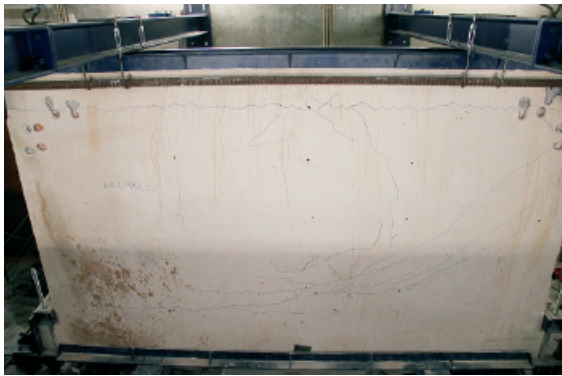
Figure 26. Crack pattern after out-of-plane test

noticeable. The maximum load is 49.34 kN for a displacement of 27.85 mm in the center of the panel. Figure 26 presents the crack pattern after the out-of-plane test was done.

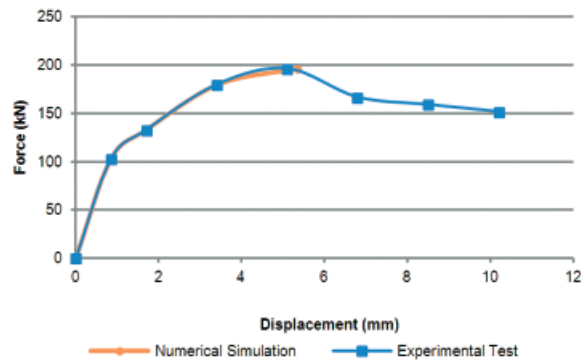
Figure 31. Numerical Simulation WALL\_REF\_01 out-of-plane test

In finite element models that represent the out-of-plane test, “compatible nodes” to define the interface were used. These were calibrated according to the stiffness that the interface displayed in the *yy* direction for different load levels. In order to simulate the out-of-plane test four loads were applied on the masonry model, placed geometrically as in the experimental test. The next figures (Figure 31, Figure 32

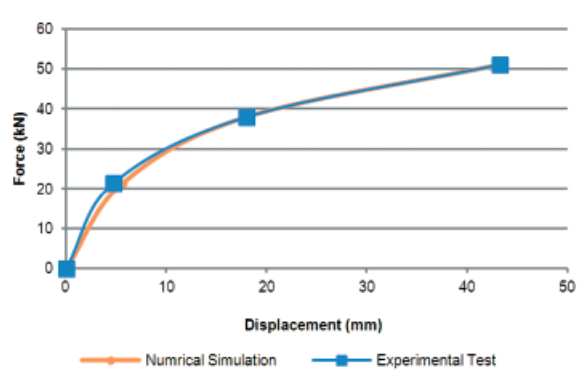
Figure 32. Numerical Simulation WALL\_JAR\_02 out-of-plane test
